MOANATAIARI SUBDIVISION, THAMES, SCOPING REPORT - HISTORICAL CONTAMINATION REVIEW

**PREPARED FOR:
Environment Waikato**

JUNE 2010

REPORT: MOANATAIARI SCOPING REPORT

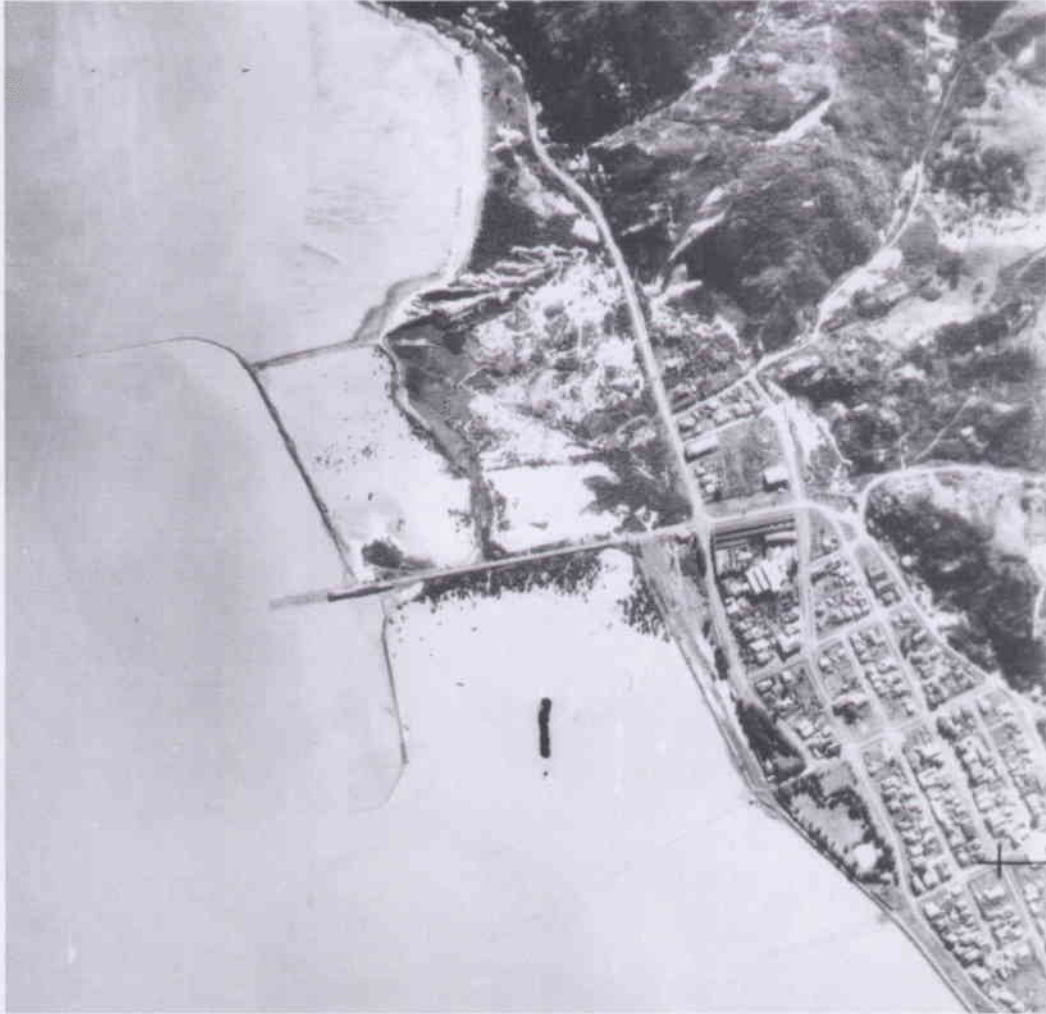
MOANATAIARI
SK01
1940

- 3.1.1 Reproductions of aerial photos are included in this report as SK01 (1944) and SK02 (1985) and are located in Appendix C.
- 3.1.2 The 1940 (SK01) reproduction shows the boundary of the Moanataiari subdivision as being very close to today's boundary. The Burke Street causeway and wharf and western sea wall are present in what appears to be the same location as today. The northern seawall appears to be in the same location as today but at Kuranui Bay the wall protrudes more to the north. The following roads are present: Queen Street (State Highway 25); Tararu Road; Coromandel Street; Haven Street; and Burke Street. Structures are present east of Tararu Road and South of Coromandel Street. No structures are present to the north east beyond Coromandel Road and west of Tararu Road. The dark patch to the west of Coromandel Road implies infilling has occurred up to two thirds along the seawall's length. The lighter patches within this dark patch to the north are more than likely non vegetated infill or possibly non contoured 'hummocky' fill. The lighter patches in the darker patch to the south could either be sea or non vegetated fill. The lighter patch between the seawall and the dark patch is more than likely seawater. Beyond the seawall to the south, immediately adjacent, is a small dark patch indicating infilling. Beyond is sea. Development is present beyond Burke Street. To the north Kuranui Bay is similar to today's outline. To the west are the foothills of Thames.

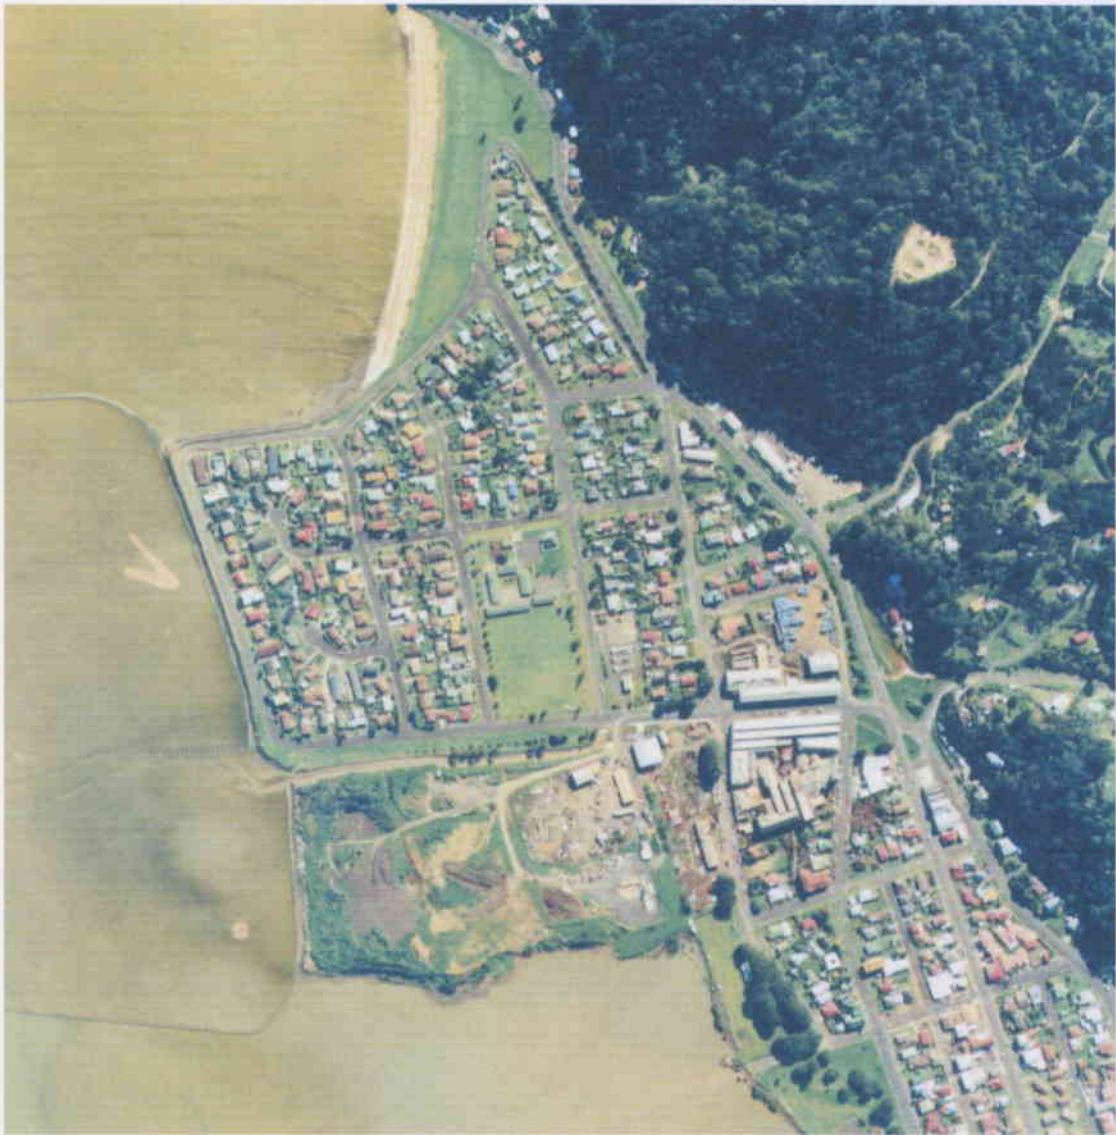
- 3.1.3 The 1985 (SK02) reproduction is vastly different to the 1940 reproduction. The land within the seawall has been completely infilled and developed. Development appears to be completed. All roads are present and all parcels of land appear to have been built on. The school is clearly visible. The surroundings environs are similar with the only real change infilling of the land to the south beyond the Burke Street causeway.

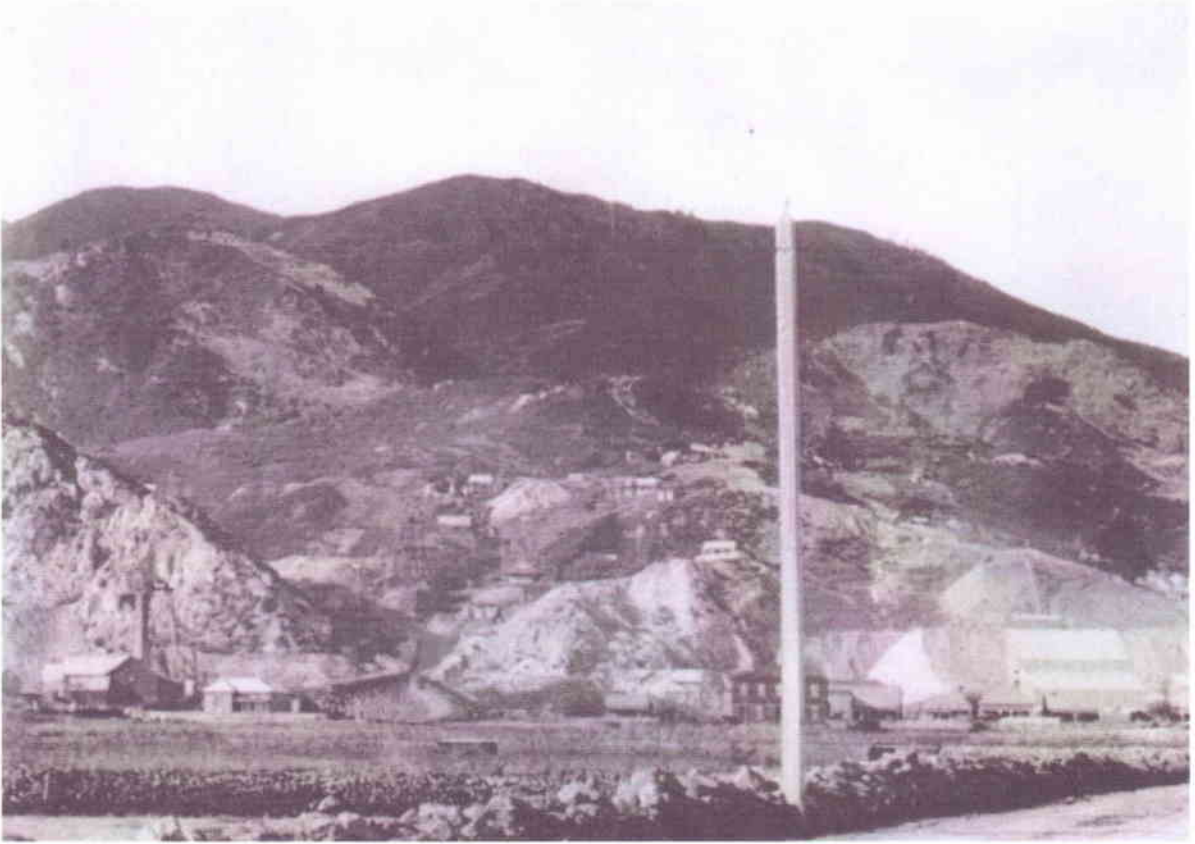
CSI Contaminated Site Investigations 80 Cook Street Hamilton	MOANATAIARI
	SK14
	1898

- 3.3.7 The 1898 (SK14) photo reproduction is taken from the Burke Street causeway looking back to Thames foothills with Moanataiari Creek in the centre. The causeway has been constructed out of rock and soil. The sea is clearly visible adjacent to the causeway. The beach or reclaimed land appears to be deep and contoured upwards to the coast. In the background before the foothills are a number of buildings which are dwarfed by large mounds of mullock and or tailings.
