Property of David and Alison Sellars  
**1149 Honikiwi Road**  
**Otorohanga**

Land Use Capability Assessment  
and  
Soil Conservation Recommendations

February 2015

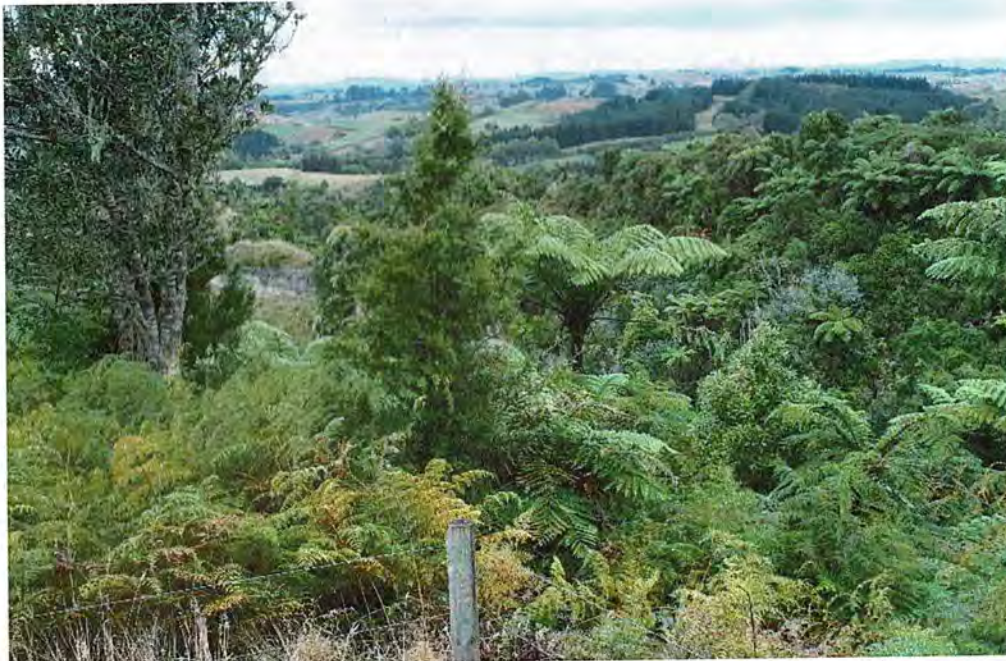
Fig 1: Sm. Massive sandstone. An outcrop of sandstone on a ridge crest.

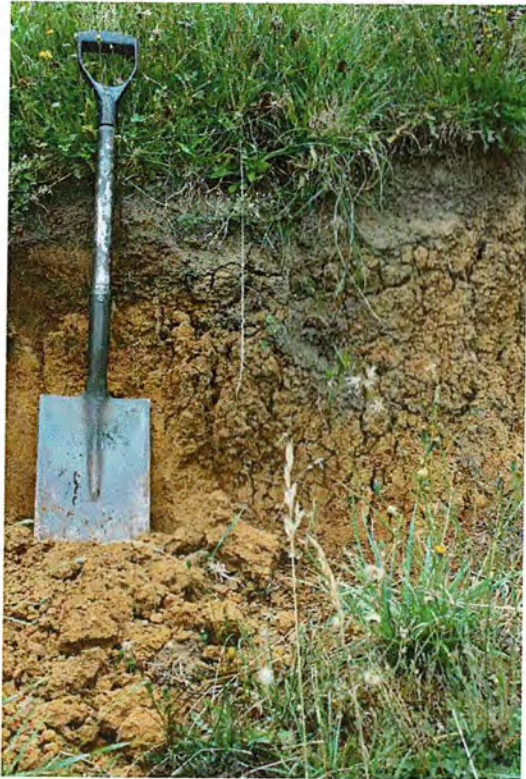
**Fig 2:** Soil recorded as Te Kuiti silt loam (60). Very friable topsoil, prone to sheet, rill or wind erosion when cultivated.

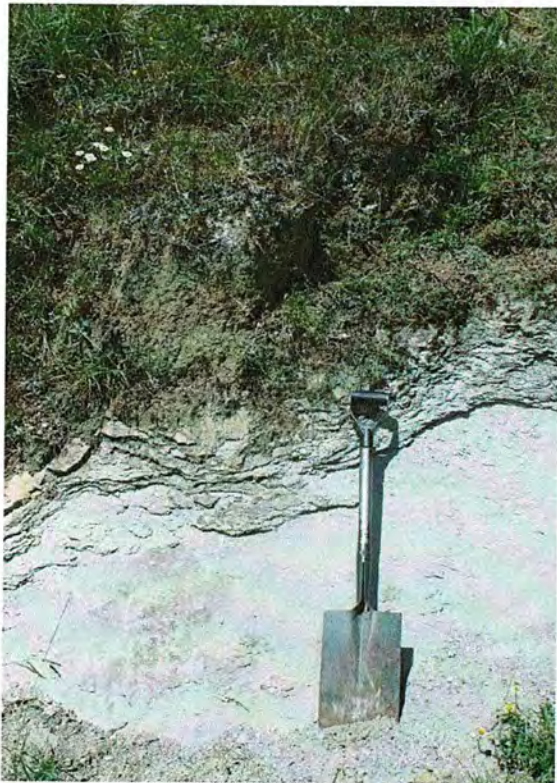
**Fig 3:** Steepland soil on sandstone, recorded as Mokau sandy loam (117c).

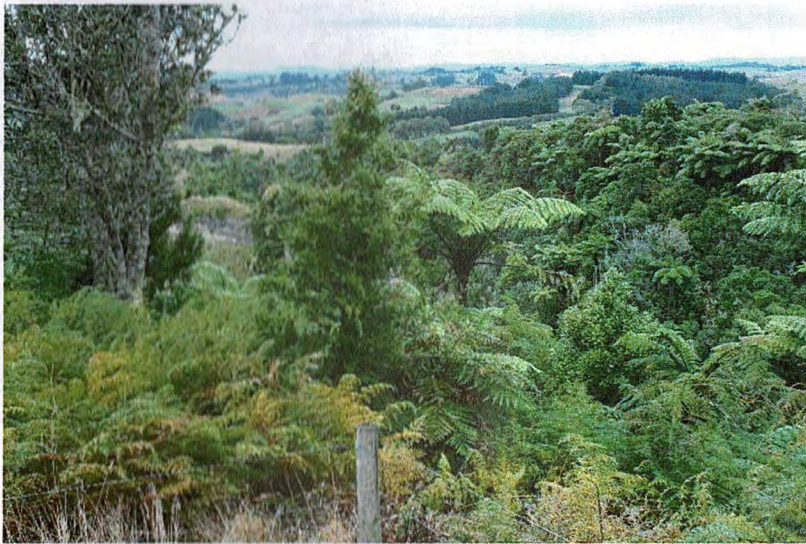
**Fig 4:** Mapped as lowland podocarp broadleaf forest (fO) providing quality catchment protection.

LUC Unit 6e8 (6.2 ha). Very steep to steep slopes with ash over massive sandstone. Currently, this unit is under native forest which has been retired. If developed, it would be susceptible to sheet and slip erosion. Slips remove all the ash leaving a hard sandstone surface which takes a long time to regenerate. See Fig 4 which identifies LUC unit 8s1 forming bluffs with LUC unit 6e8 forming the valley sides.

LUC Unit 8s1. Near vertical bluffs with no significant agricultural values, and mapped as a complex with LUC unit 6e8. The bluffs provide a refuge for native scrub and possibly rare vegetation types. See Fig 4 in which a sandstone bluff can be seen through the trees.

The forest area provides a beautiful backdrop to the house. The electric fence surrounding this forest is doing its job at the moment but for long term protection a more permanent fence needs to be planned. Looking even further ahead to a time when the property could be sold this block would benefit from being protected by a QE11 Covenant. It would be sad if the next owner did not have the same ethic as the current owner.

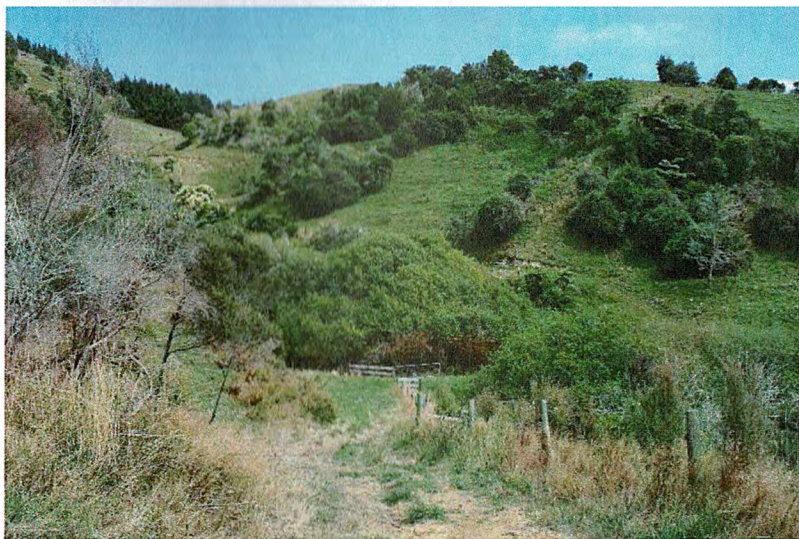
**Fig 5:** A mix of semi improved pasture and scattered exotic scrub on LUC unit 6e1 on the far hill face. Note some sheet erosion along the fence line and willow in the drainage line (LUC unit 7w1).

LUC Unit 6e1 (7.7 ha). (See Figs 5 and 6). Moderately steep hill country slopes, too steep for cropping, but with a relatively deep mantle of ashes. The unit contains steeper sections usually in the form of small valleys which may have seepage zones or springs at their head. Stock tracking occurs on slopes steeper than 20°. Soils are recorded as Te Kuiti silt loam and Tumutumumu silt loam. Exotic scrub spp such as privet and gorse reduce carrying capacities.

LUC Unit 7w1 (0.7 ha). Wet drainage lines, wetlands and waterway, currently with wetland vegetation and some grazed with cattle. Willows clog up parts of the drainage line. These need to be removed and replaced with native vegetation. Where the wetland areas are dominated by wetland vegetation there is a quality nutrient stripping environment. See Fig 5 which identifies the LUC unit 7w1 waterway clogged with willows immediately above the dam wall.

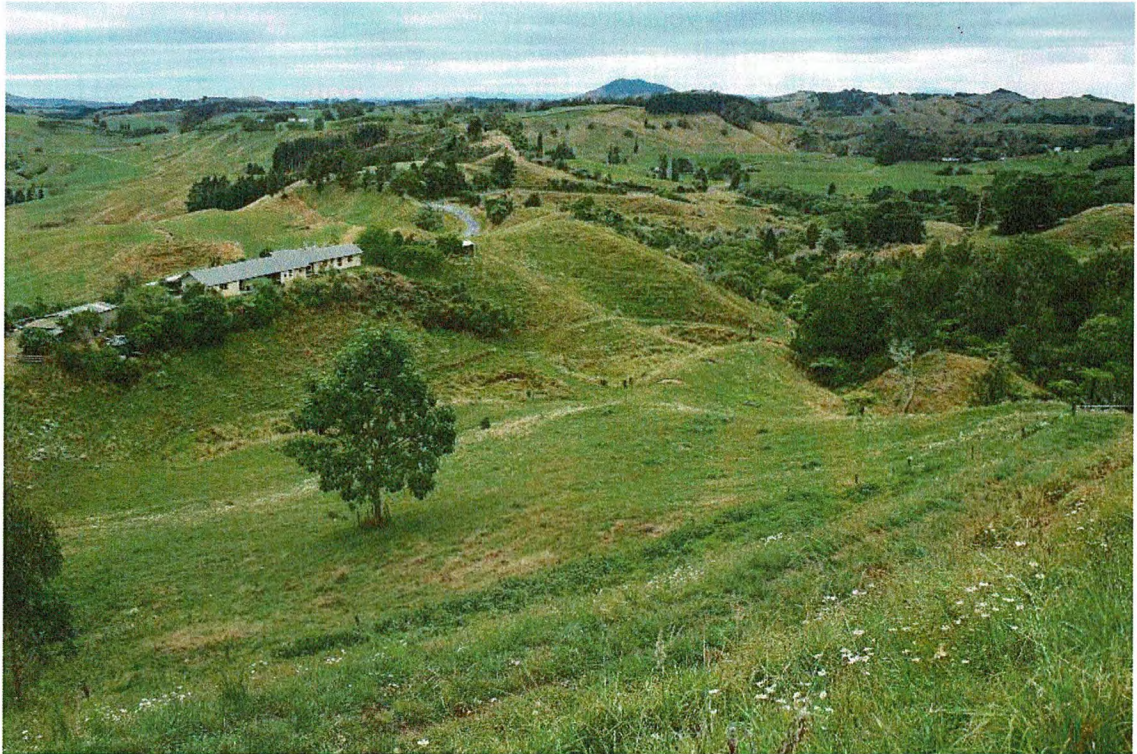
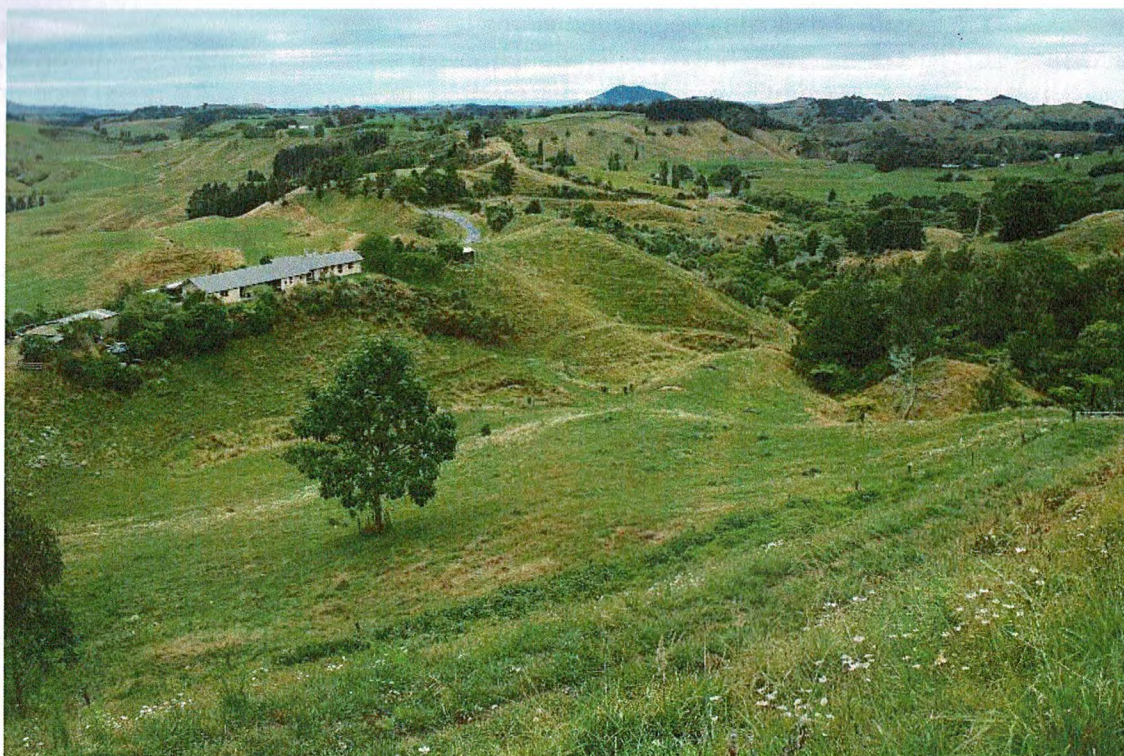
**Fig 6:** A mix of semi improved and improved pasture spp on LUC unit 6e1 on the side slopes, with LUC unit 4e3 in the lower valley areas.

LUC unit 4e3 (1.1 ha). (See Fig 6). Rolling to strongly rolling slopes with a deep mantle of ashes. These units are very productive under pasture. They can be cultivated for cropping but the risk of soil loss is high due to the potential for sheet and rill erosion. Minimum tillage or, at least, cultivation on the contour with grass strips each 100 m is needed with cultivation preferably only as part of a pasture renewal rotation. Fodder crops such as maize are suitable in a rotation.
