Draft Whangamata Catchment Management Plan

21 November 2006

Document #: 1194680

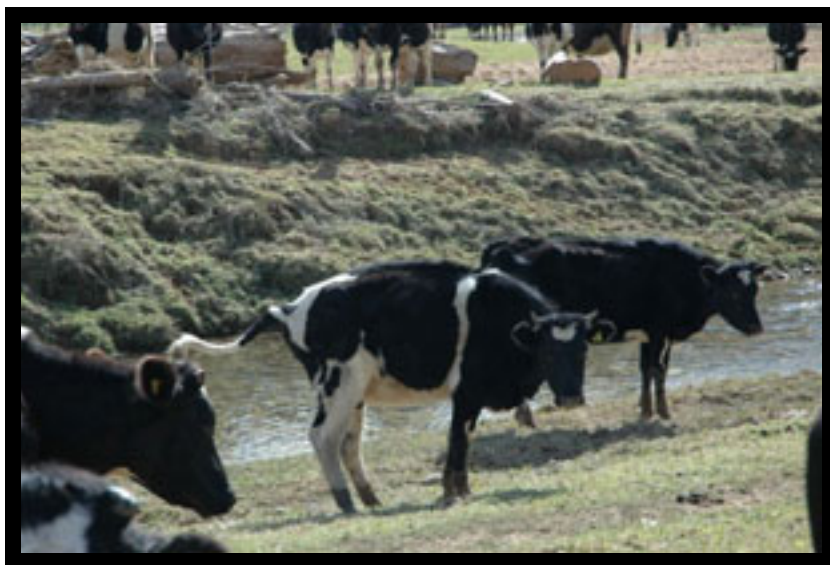
Approximately 70 per cent of the main Wentworth channel is fenced to stock class standard and prevents stock from accessing the stream bed. Of the seven tributaries in this catchment area only the Wairoa Stream has any significant riparian protection (90 per cent fenced, good riparian (stream bank or river bank) cover 90 per cent).

Figure 4. Cattle next to the Wentworth River

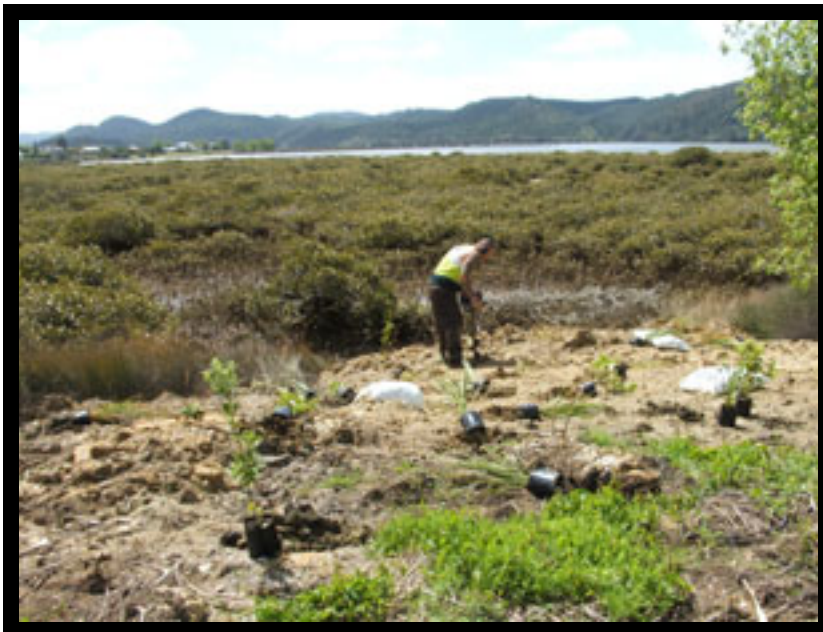
Figure 7. Planting on coastal margin of Te Weiti Stream

- Regular maintenance of the stream channel through the mangroves into the harbour.
- Upgrade the stream fence and plant with appropriate natives.
- Maintain existing silt traps.
- Investigate potential in this area to carry out coastal wetland enhancement for biodiversity purposes.
