Waikato Regional Council  
Technical Report 2024-06

# Kāwhia

## Catchment Management Plan

# Kāwhia Catchment Management Plan: Supporting Information

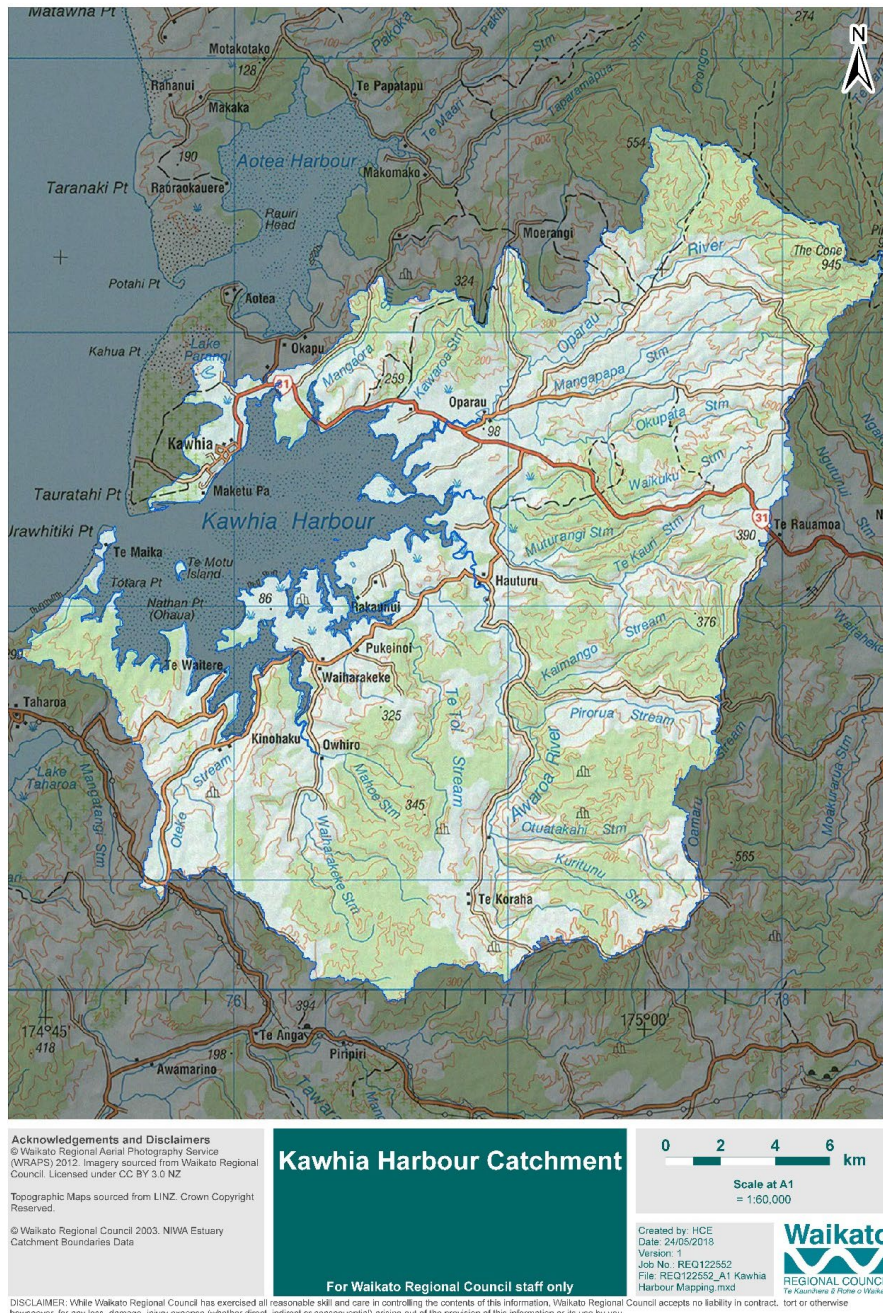
Figure 1. NZ Topographic map of the Kāwhia catchment.

The Kāwhia Harbour catchment covers approximately 48,000 hectares of land along the west coast of the North Island of New Zealand (Figure 1). The Kāwhia catchment includes 709 kilometres of streams<sup>1</sup> and has been split into seven sub-catchments for management purposes by Waikato Regional Council: Kāwhia, Mangaroa, Oparau, Te Kauri, Awaroa, Te Toi, and Waiharakeke (Figure 2).

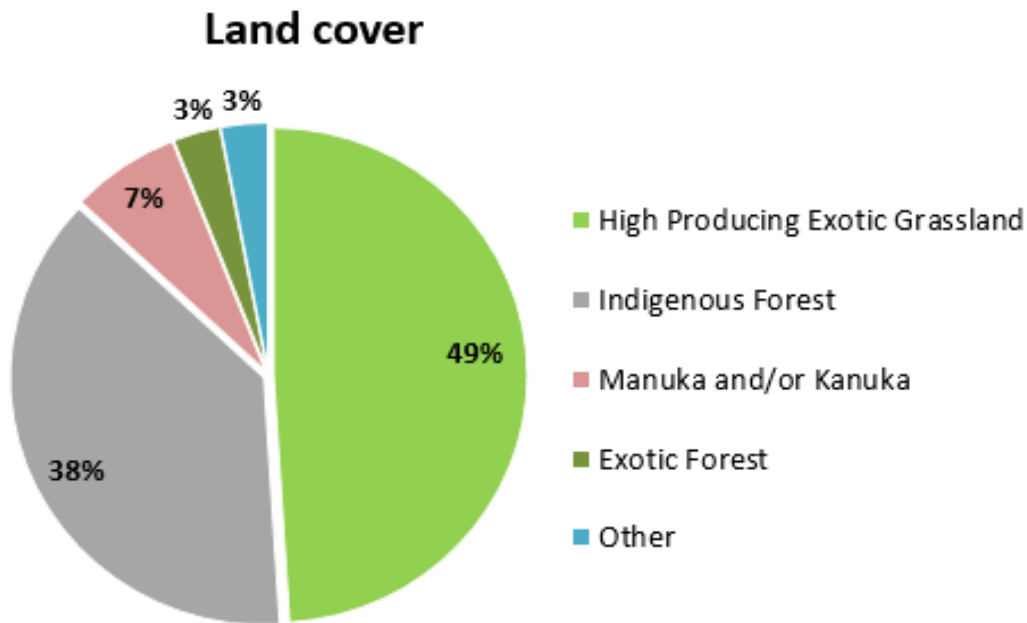
Figure 4. Land cover in the Kāwhia Harbour catchment (Singleton, 2018).

The current land cover within the Kāwhia Harbour Catchment is shown in Figure 3 and is summarised in a graph in Figure 4. Almost half of the Kāwhia catchment is in pasture (49%) and the rest is in native woody cover (45%) with some exotic forestry (3%), wetland and sand. Around 38% of the catchment is covered in indigenous forest which is generally found near the outskirts of the catchment boundary, but patches can be found throughout the catchment. The mid to low lying areas of the catchment are generally dominated by high producing exotic grassland with some manuka/kanuka and exotic forestry scattered amongst these areas. There is very minimal built-up area within the catchment.

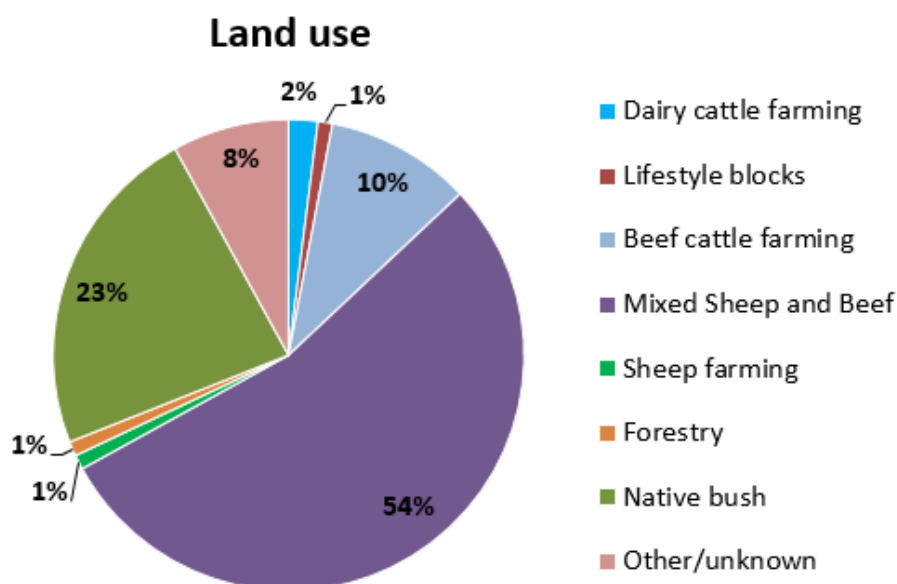
Figure 7. Land use types within the Kāwhia catchment (Singleton, 2018)

There are three main land use categories in New Zealand: production, conservation, and urban and rural development. Figure 7 shows the different land use classes within the Kāwhia catchment. It is noted that there are some gaps in the data regarding the exact proportions of land use in the catchment. However, the predominant land use within the Kāwhia catchment is pastoral sheep and beef farming, which is estimated at 54% of the catchment, followed by native bush (23%) (Singleton, 2018).

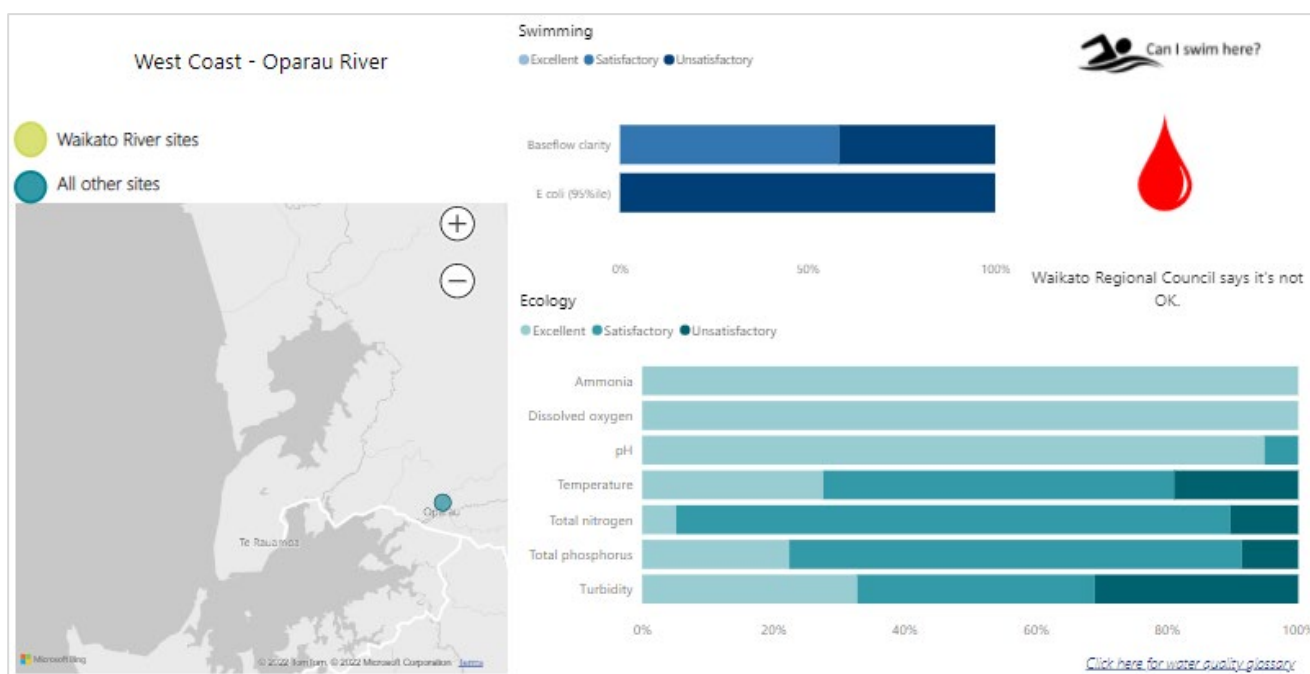
Figure 11. Average (2016-2020) results of monitoring (ecological health and suitability for swimming) at the Oparau River monitoring site as displayed at the Waikato Regional Council Environmental Monitoring Hub website.<sup>12</sup>

Waikato Regional Council's Environmental Indicators website provides summary data for the 2016-2020 period (Figure 11, Table 5) and this information indicates that the Oparau River was not considered to be safe for contact recreation (swimming) over that period. This was due to high levels of *E. coli* (100% of the time) and unsatisfactory clarity (at baseflow) measurements (42% of the time). The Oparau River met standards for ecological health most of the time (Table 5), with some unsatisfactory measurements of temperature, turbidity, and plant nutrients (nitrogen and phosphorus).

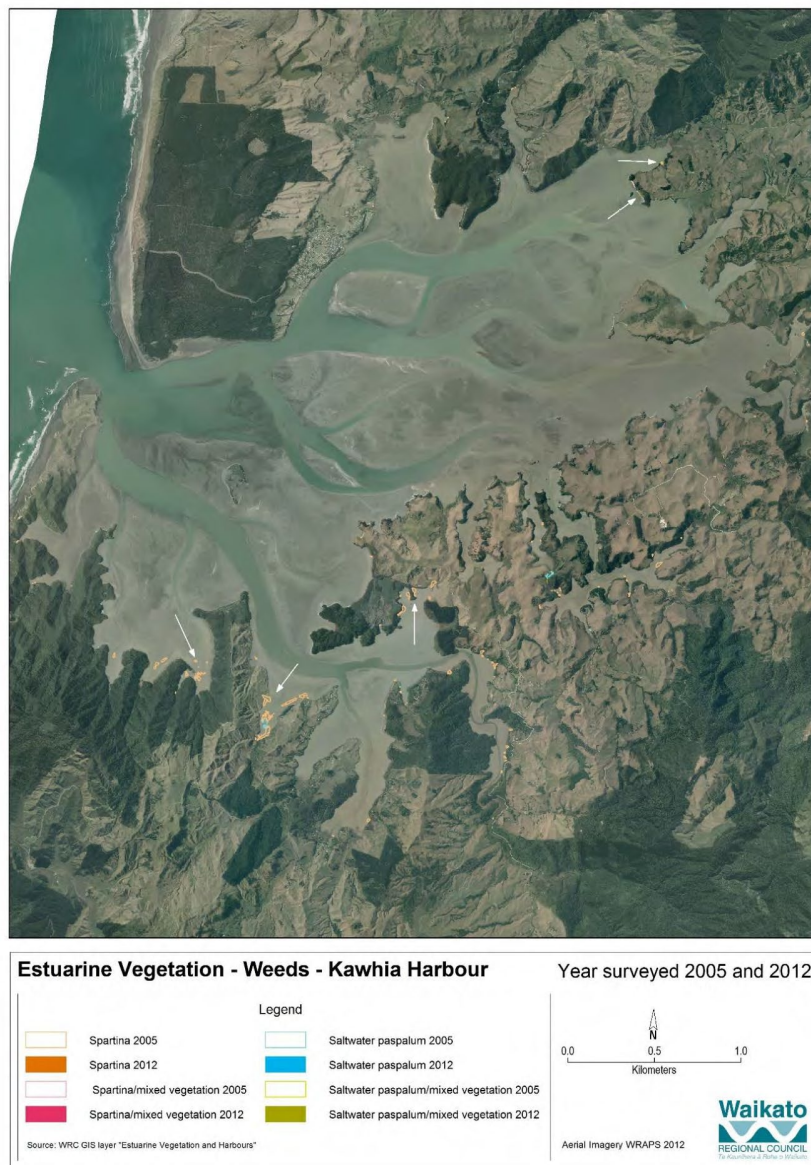
Figure 21. Spartina and saltwater paspalum distribution in Kāwhia Harbour. Source: Bouma (2016).

Tiritirimatangi Peninsula and the Awaroa River arm within Kāwhia harbour were identified as important “within estuary” areas for saltwater paspalum control in Kāwhia (Graeme & Kendal 2014).

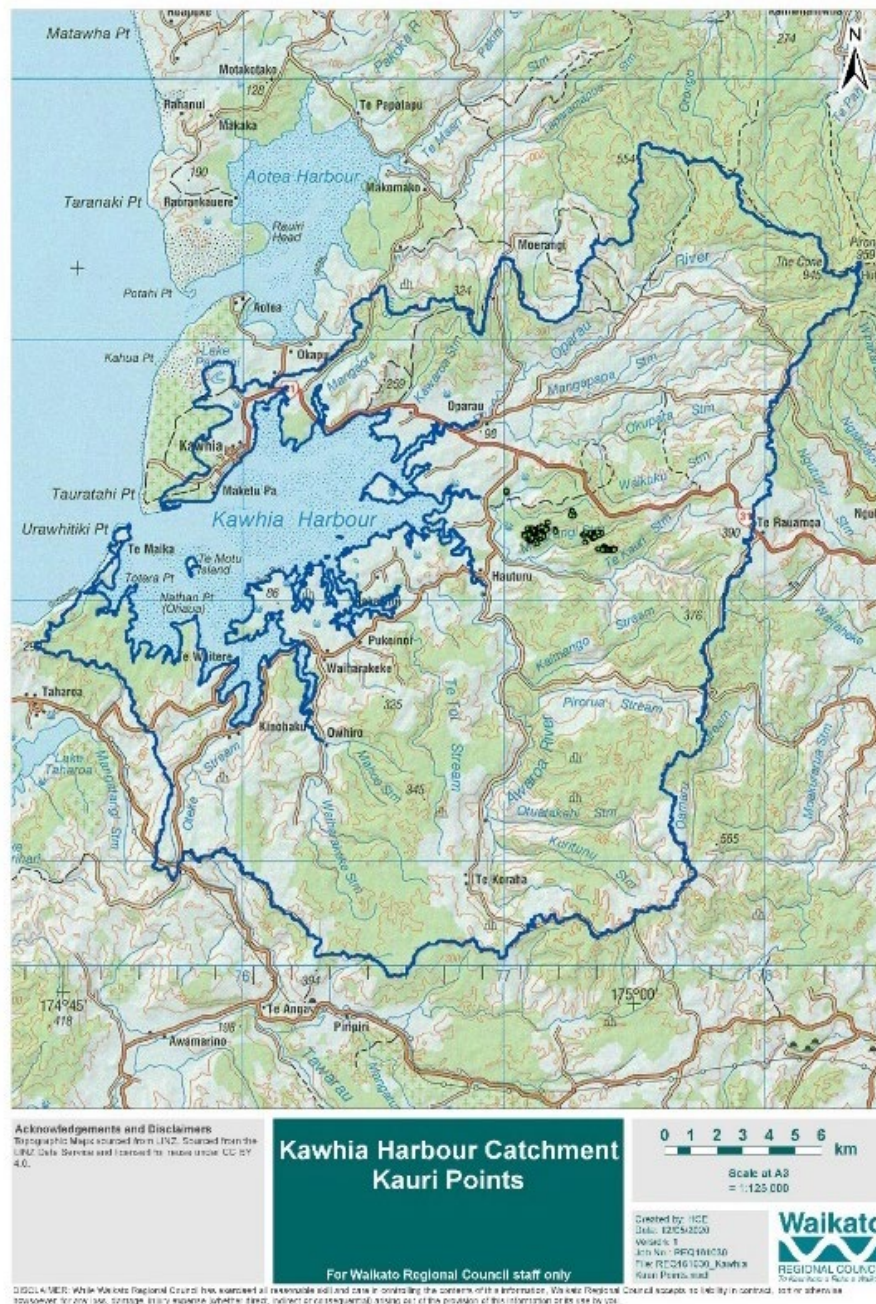
Figure 22. Location of Kauri within Kāwhia Harbour Catchment (black outlined circles).

Naturally occurring kauri are found throughout the warmer regions of the upper North Island as far south as Kāwhia, which is the natural southern-most distributional limit Figure 22. The mature stands of kauri within the Kāwhia area are significant in that they represent the southern-most limit of the species in New Zealand and appear to be clear of disease.
