# Awakino oil spill report

Prepared by:  
Dave Lovatt

For:  
Waikato Regional Council  
Private Bag 3038  
Waikato Mail Centre  
HAMILTON 3240

13 July 2011

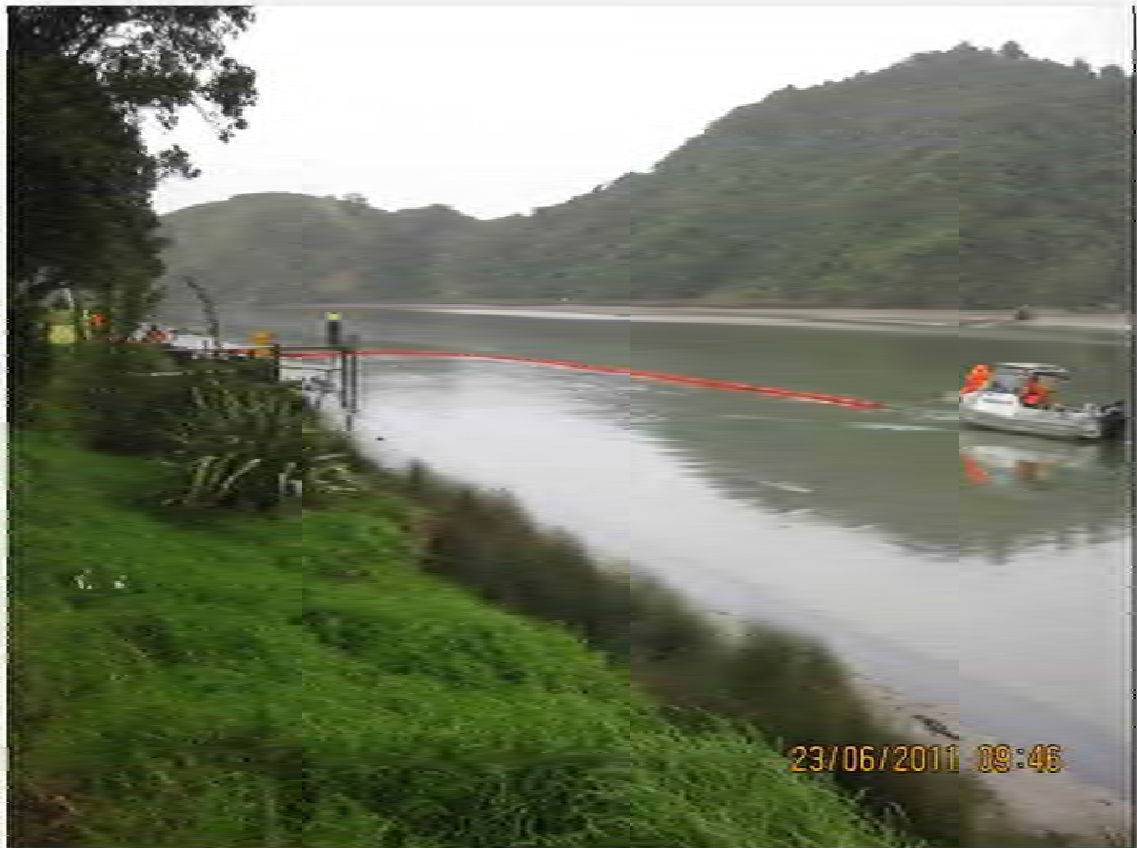
Figure 2: Site of the oil spill recovery operations. Source: WRC doc # 2000188.

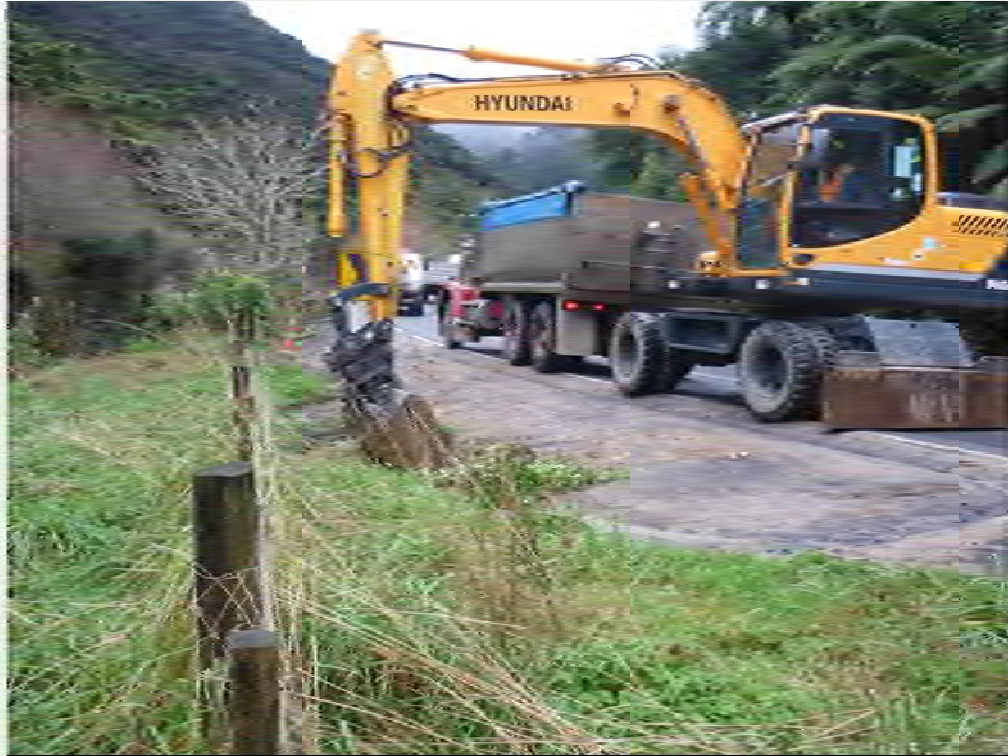
**Figure 3: Support vehicles assisting in the clean up operation at the crash site on SH3 in the Awakino Gorge (WRC doc # 2009154).**

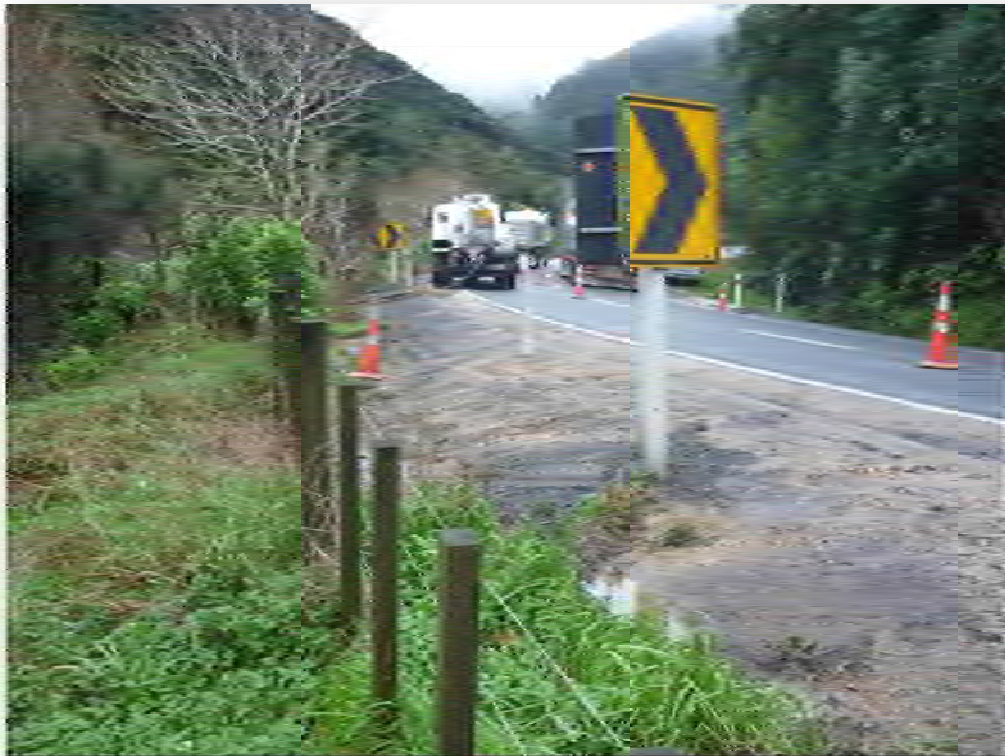
**Figure 4: Crash site after remedial works (WRC doc # 2009154).**

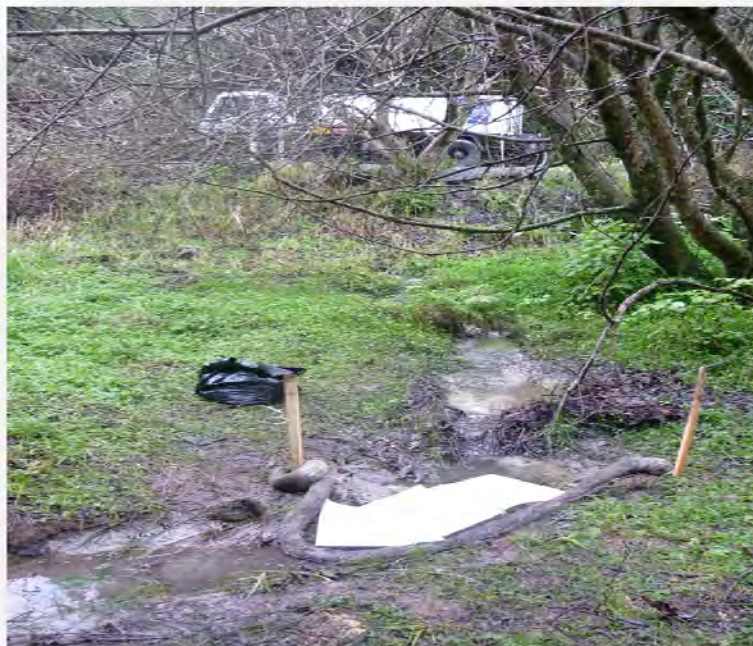
**Figure 5: Sorbent pads and booms were positioned on the river banks at the spill in an attempt to recover oil in the ground and intercept from leaching into the river. (WRC doc # 2009154).**

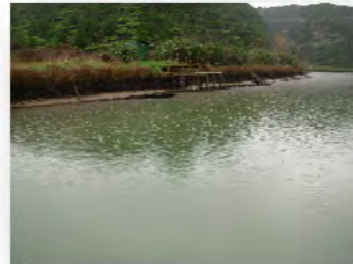
It was reported that by the time the staff had arrived on site there was very little chance of containment on land as most of the oil had directly entered the Awakino River. By first light in the morning it appeared obvious that most of the oil had travelled down the river and exited the estuary out to sea. There were still remnant remains of oil on the river and in particular the tidal or estuarine section of the river. It was observed that there was still a solid slick of oil on the windward side of the Awakino river banks. There was oil also coating the reeds and sand/mud on the side of the river bank.

**Figure 6: WRC Doc # Unknown. The extent of oil adhering to the banks and reeds of the river**

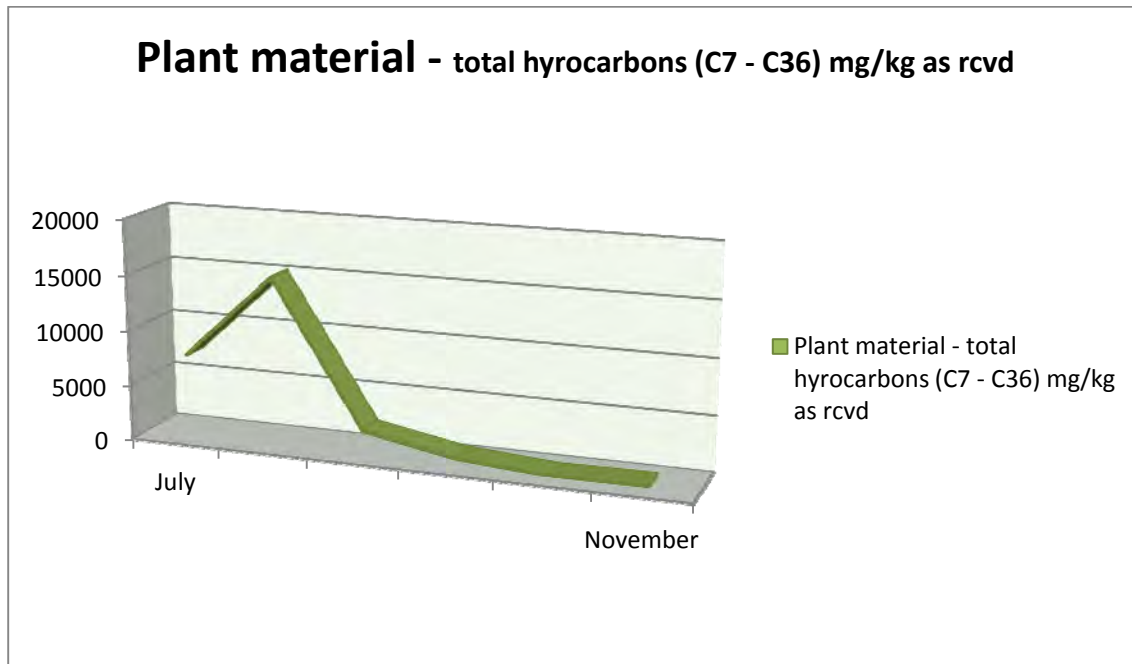
05 <sup>th</sup> July	7500 mg/kg as rcvd
21 <sup>st</sup> July	15200
18 <sup>th</sup> Aug	2200
22 <sup>nd</sup> Sept	660
20 <sup>th</sup> Oct	65
18 <sup>th</sup> Nov	149
19 <sup>th</sup> Dec	<40

Although the graph appears to continue to trend downward there was a slight lift in hydrocarbon levels in the last test.
