MOANATAIARI SUBDIVISION, THAMES, SCOPING REPORT - HISTORICAL CONTAMINATION REVIEW

**PREPARED FOR:
Environment Waikato**

JUNE 2010

REPORT: MOANATAIARI SCOPING REPORT

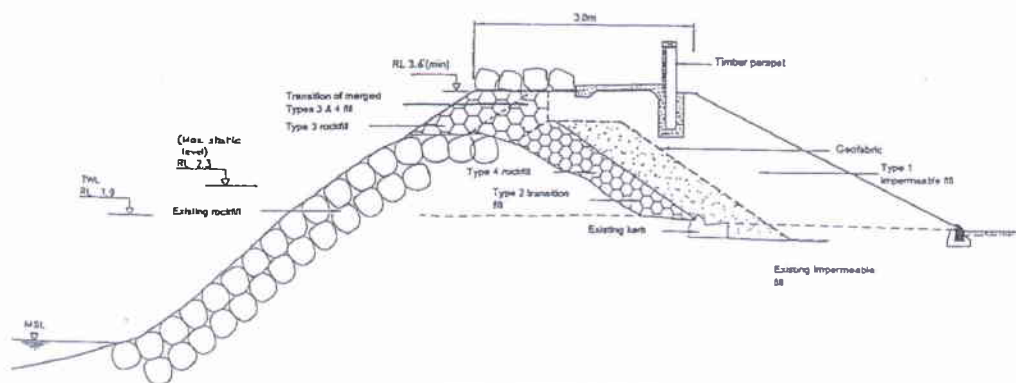
TYPICAL SECTION OF SEAWALL

The subdivision was protected from the sea by a 550 m long rockfill seawall which in severe storms proved inadequate: after marching across the length of the Firth, waves and surge overtopped the wall easily. But a graver problem was the embankment's permeability: heavy surge simply flowed through the rockfill and quickly gave many residents a waterfront property.

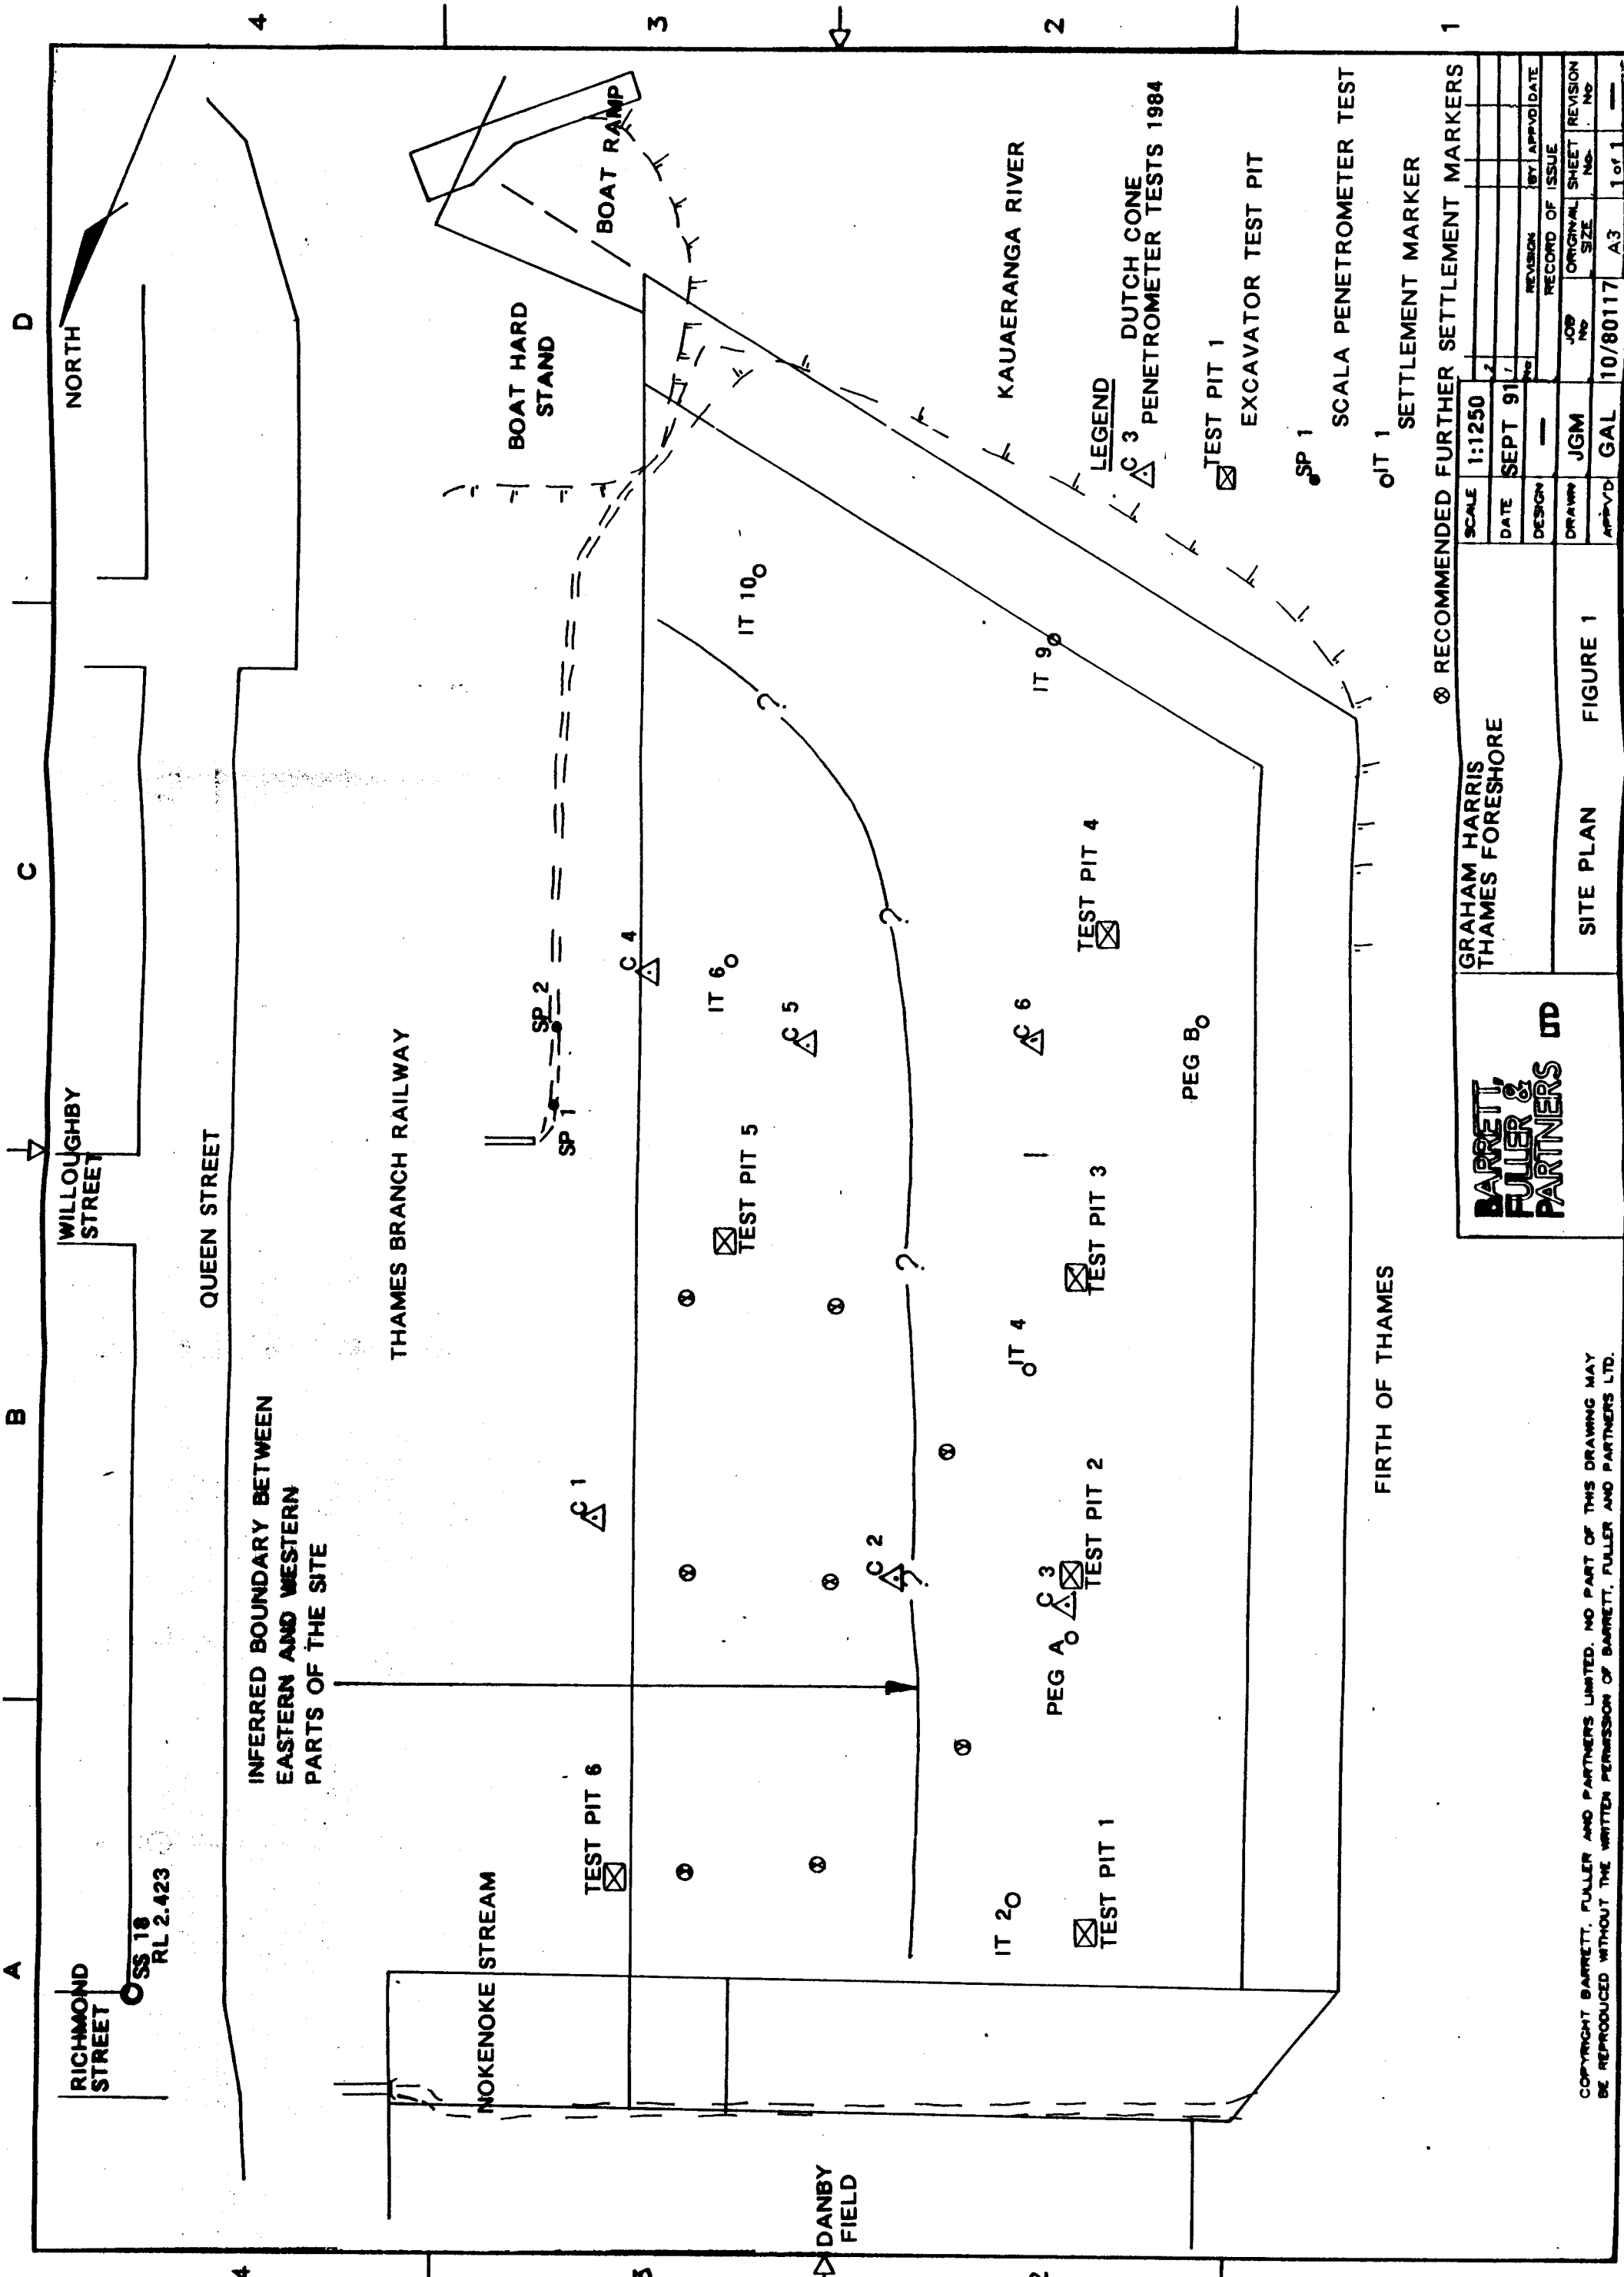
GRAHAM HARRIS THAMES FORESHORE
 SITE PLAN
 FIGURE 1

The inferred boundary between the two portions of the site (based on current plus all previous information) is shown on Figure 1. It should be viewed as tentative at this stage.

Settlement monitoring of various survey marks (locations shown on Figure 1) has been carried out by Mr Dunwoodie from 1979 to the present day.

Although some of the original marks have been lost, reasonable records exist from April 1984 to August 1991. Figure 2 plots settlement with time for I.T.'s 2,4,6,9 and 10 and Pegs A and B. It indicates approximately 6mm/year continuing settlement at I.T.6 (eastern part of the site) and typically 40mm/year at the survey marks within the western part of the site. There is evidence, however, that the settlement rate is slowing in both areas.
