Preliminary Geotechnical Assessment  
– HdGeo

**599 OREIPUNGA  
ROAD,  
MAUNGATAUTARI**

**PRELIMINARY  
GEOTECHNICAL  
ASSESSMENT**

PROJECT NO: HD2046  
MARK ANDREE-WILTENS  
REFERENCE: PGR  
27 AUGUST 2021

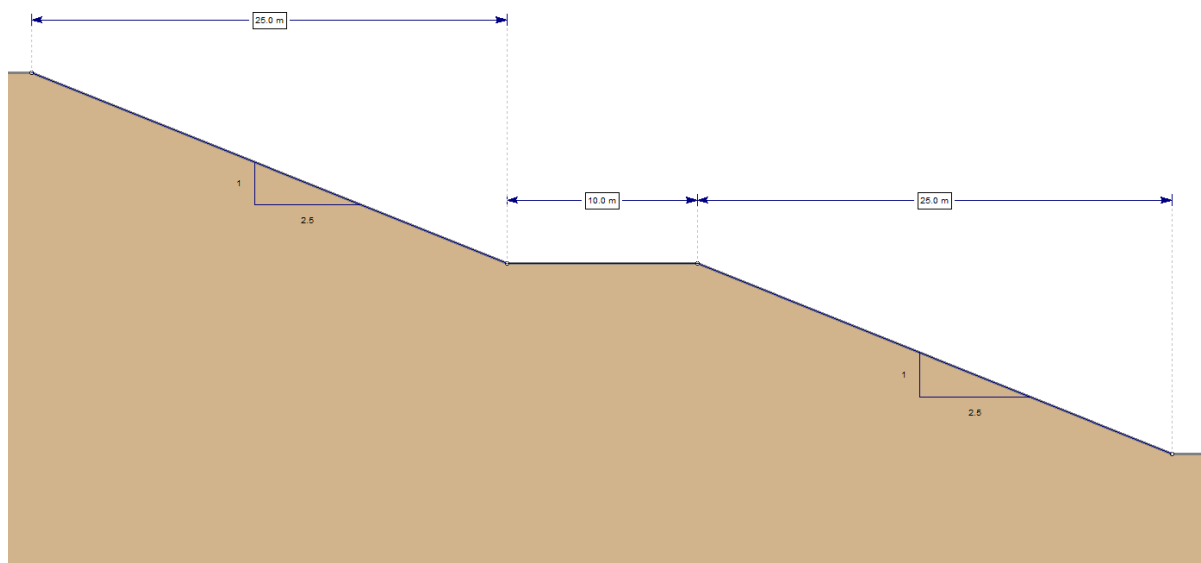
Figure 1: Final geometry of slopes

We have assessed batter slopes and benches to determine a suitable, and stable final geometry for the quarry. Final geometry of the batter slopes should be no steeper than 2.5H:1V and no higher than 10 m high. A 10 m horizontal bench can separate two, maximum 10 m high 2.5H:1V batter slopes. A schematic of the proposed final geometry can be seen in Figure 1 below.

- an excavation restriction zone 20 m wide should be applied to the gully features on the site
- the final batters should be constructed at 2.5H:1V and maximum 10 m high, two batters can be separated by a 10 m horizontal bench
- groundwater seepage from perched groundwater must be controlled appropriately to avoid erosion
- more detailed assessment will be needed for any change in the recommended geometry above (higher or steeper)
- the final batters should be vegetated to mitigate erosion

- we recommend an excavation restriction zone of 20 m be applied to the gully features on the site
- the final batters should be constructed at 2.5H:1V and maximum 10 m high, two batters can be separated by a 10 m horizontal bench
- further assessment will be needed for any change in geometry to be higher or steeper
- the final batters should be vegetated to mitigate erosion
- groundwater seepage from perched groundwater must be controlled appropriately to avoid erosion
- a quarrying management plan that includes requirements for cuts, fills and erosion control should be prepared to guide quarrying activities.

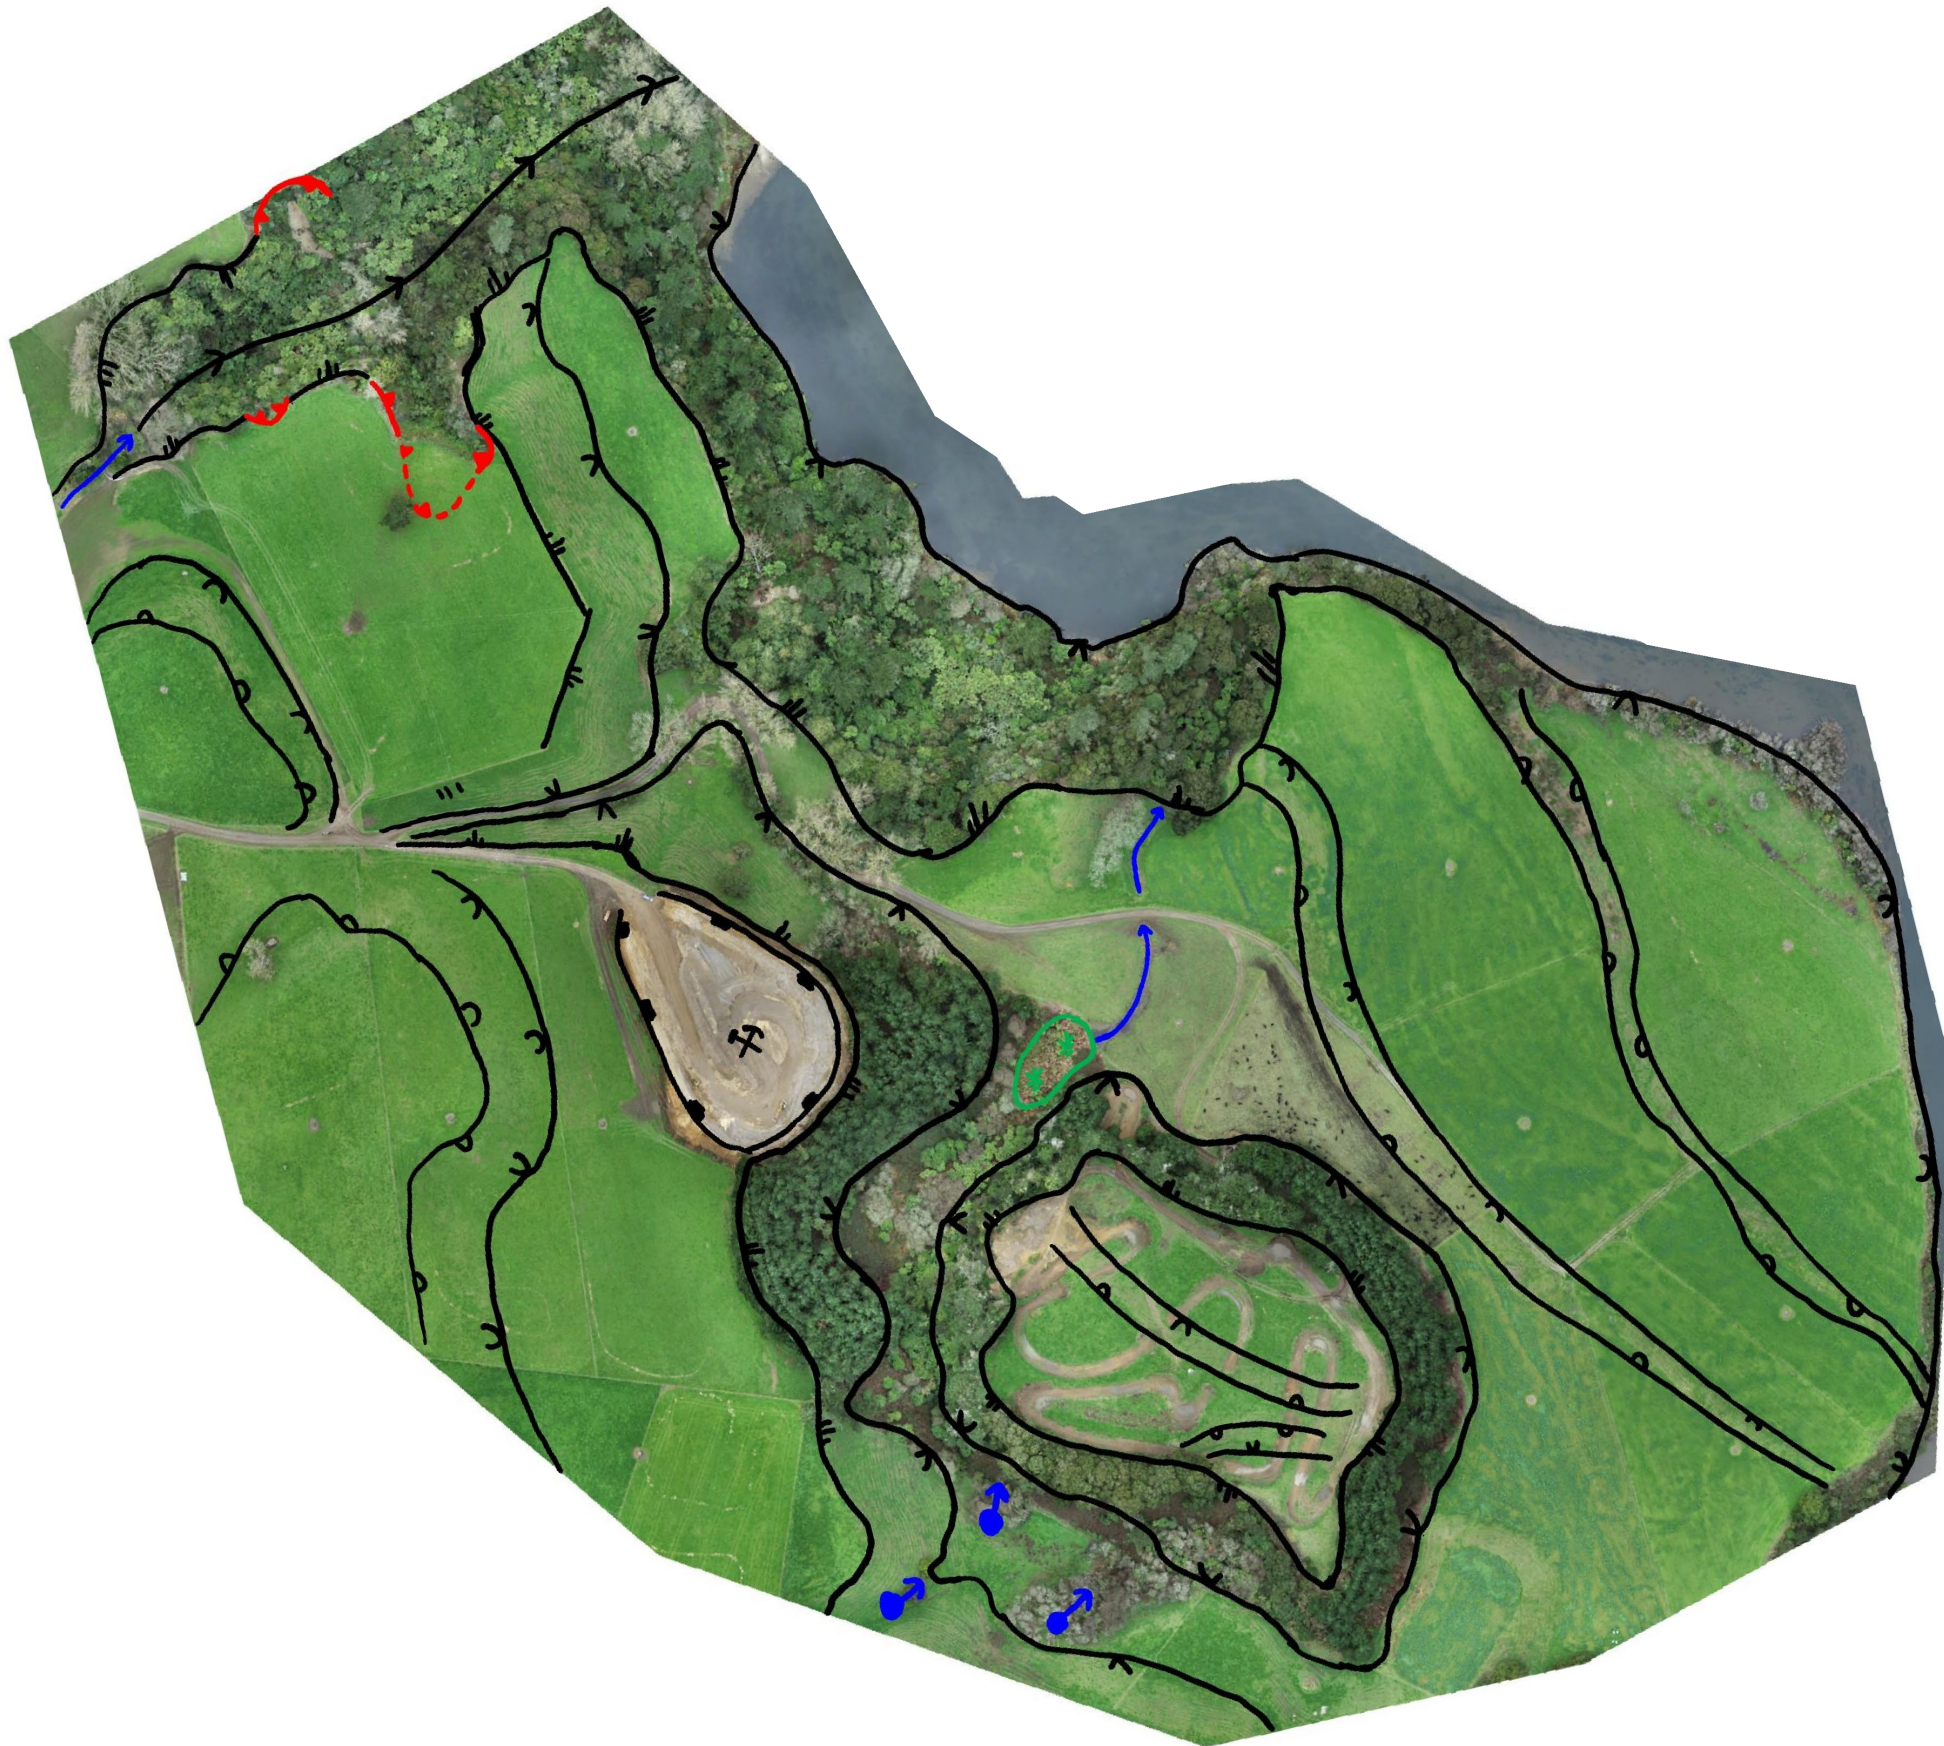
**Legend:**

Full geomorphic legend included on next page.

1. Image from HD Geo drone survey.

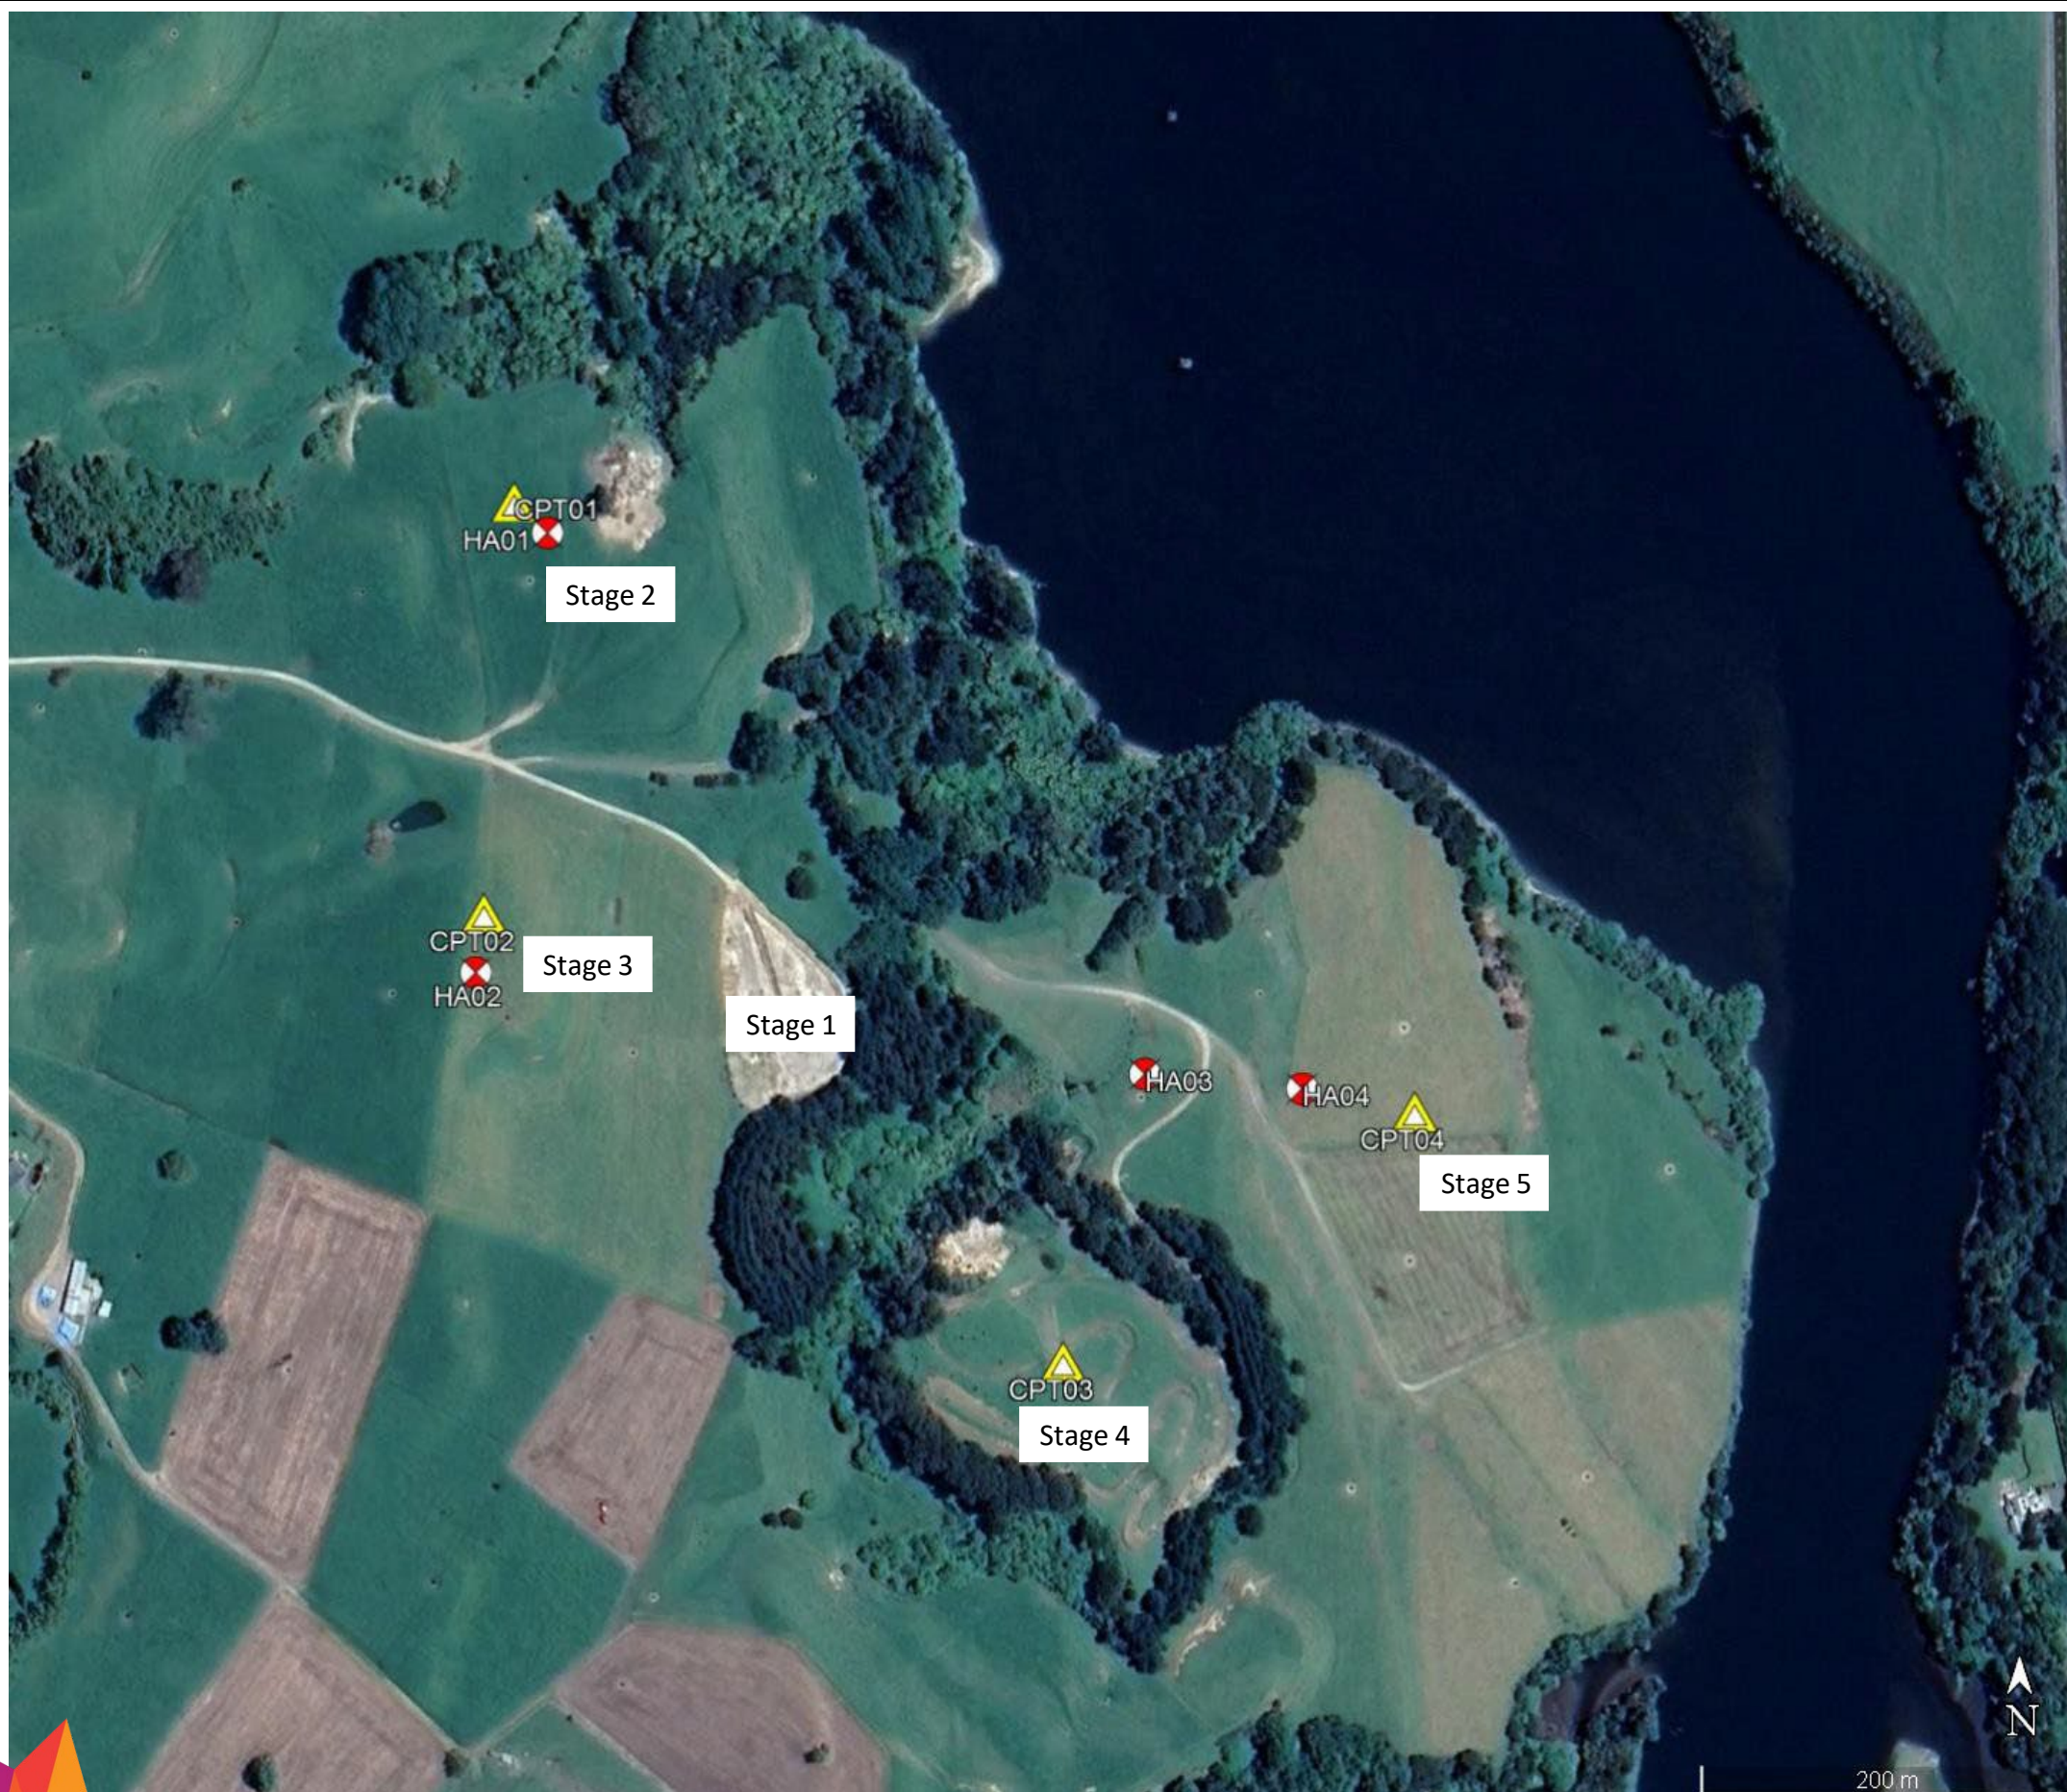
**Legend:**

- Cone penetration test
- Hand auger

1. Image from Google Earth Pro.

The materials we encountered on site during our hand auger investigation were consistent with the mapped geology across the two terraces. Ground conditions on the site are summarised in Table 2 below. Hand auger logs and locations are included in Appendix C.

Deeper ground conditions interpreted from the CPTs on the site are summarised below. CPT interpretations and locations are included in Appendix C.

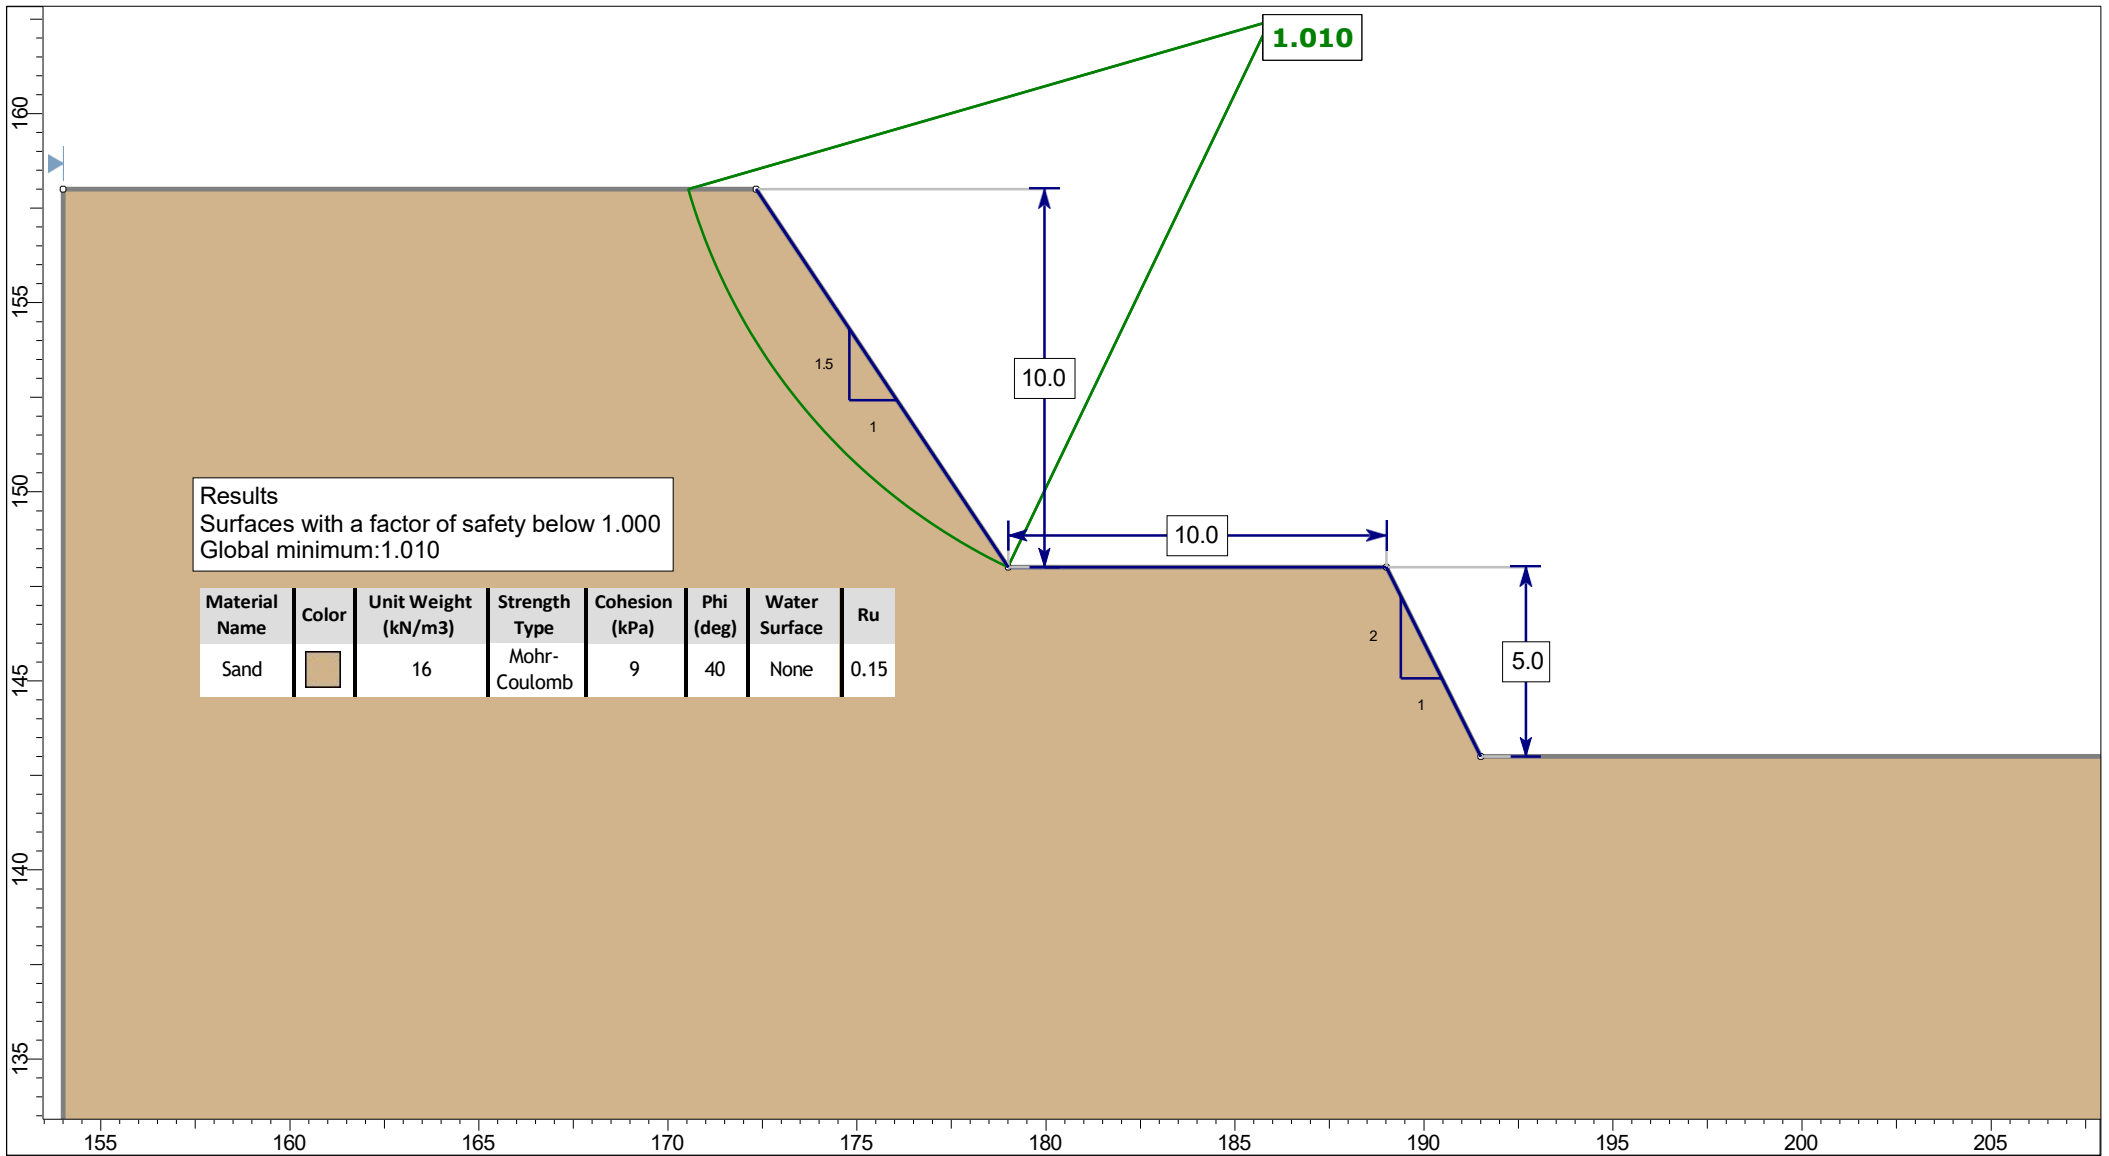
Project	599 Oreipunga Road, Maungatautari		
Group	Stage 1	Scenario	Back assessment
Drawn By	Brad Kroef	Company	HD Geo Ltd
Date	19/08/2021, 11:43:42 AM	File Name	HD2046_Stage 1 - Back assessment.slm

By assessing the slope geometry of the current quarry site, we were able to iterate our model until representative FoS values were achieved. A FoS of just over 1.0 during long term, normal ground water conditions was used as representative of the current slope conditions.

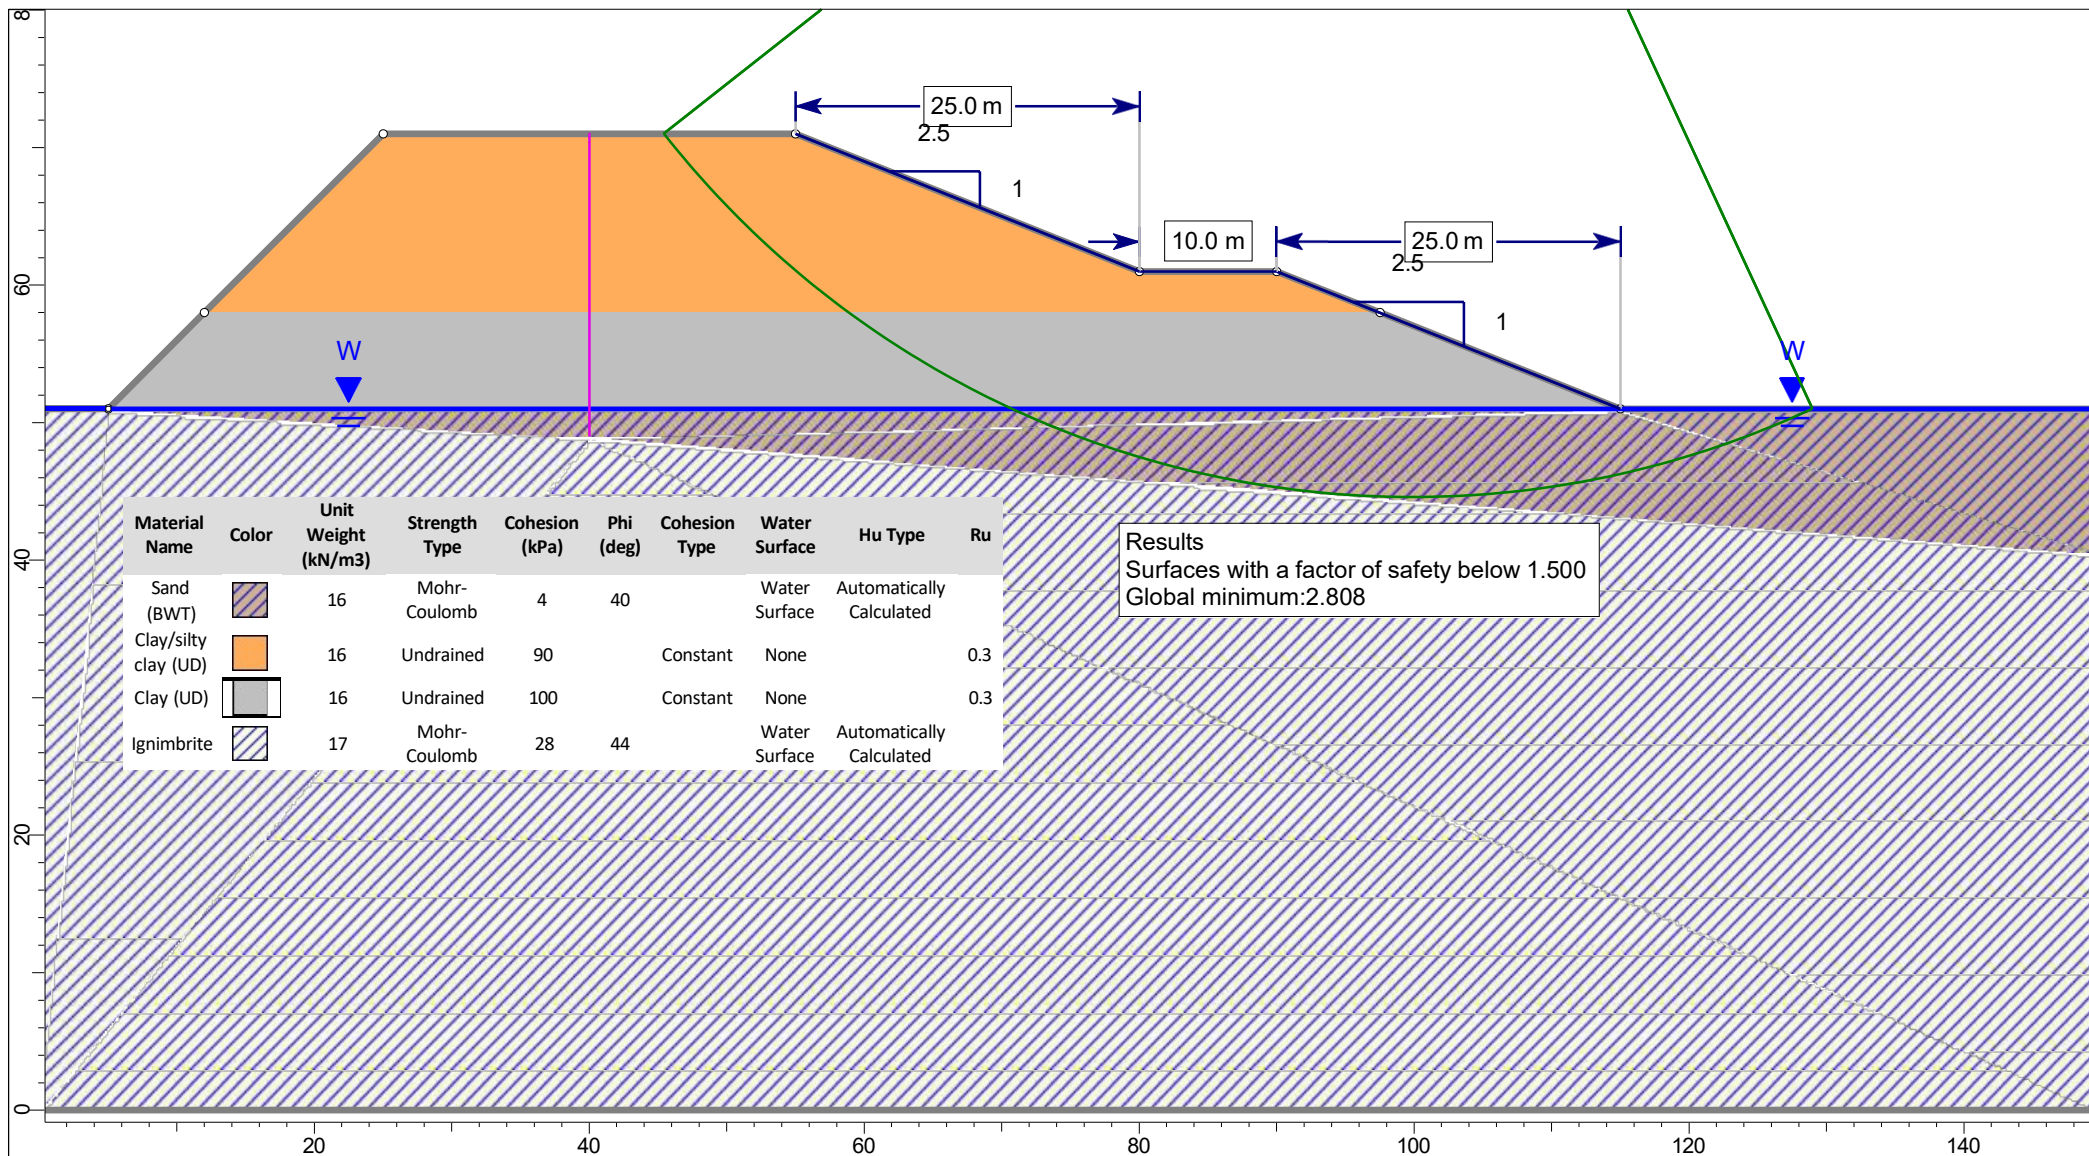
Project	599 Oreipunga Road, Maungatautari		
Group	Stage 2 - Benched (2.5:1)	Scenario	Undrained
Drawn By	Brad Kroef	Company	HD Geo Ltd
Date	19/08/2021, 12:20:44 PM	File Name	HD2046_Slide (refined).slmd

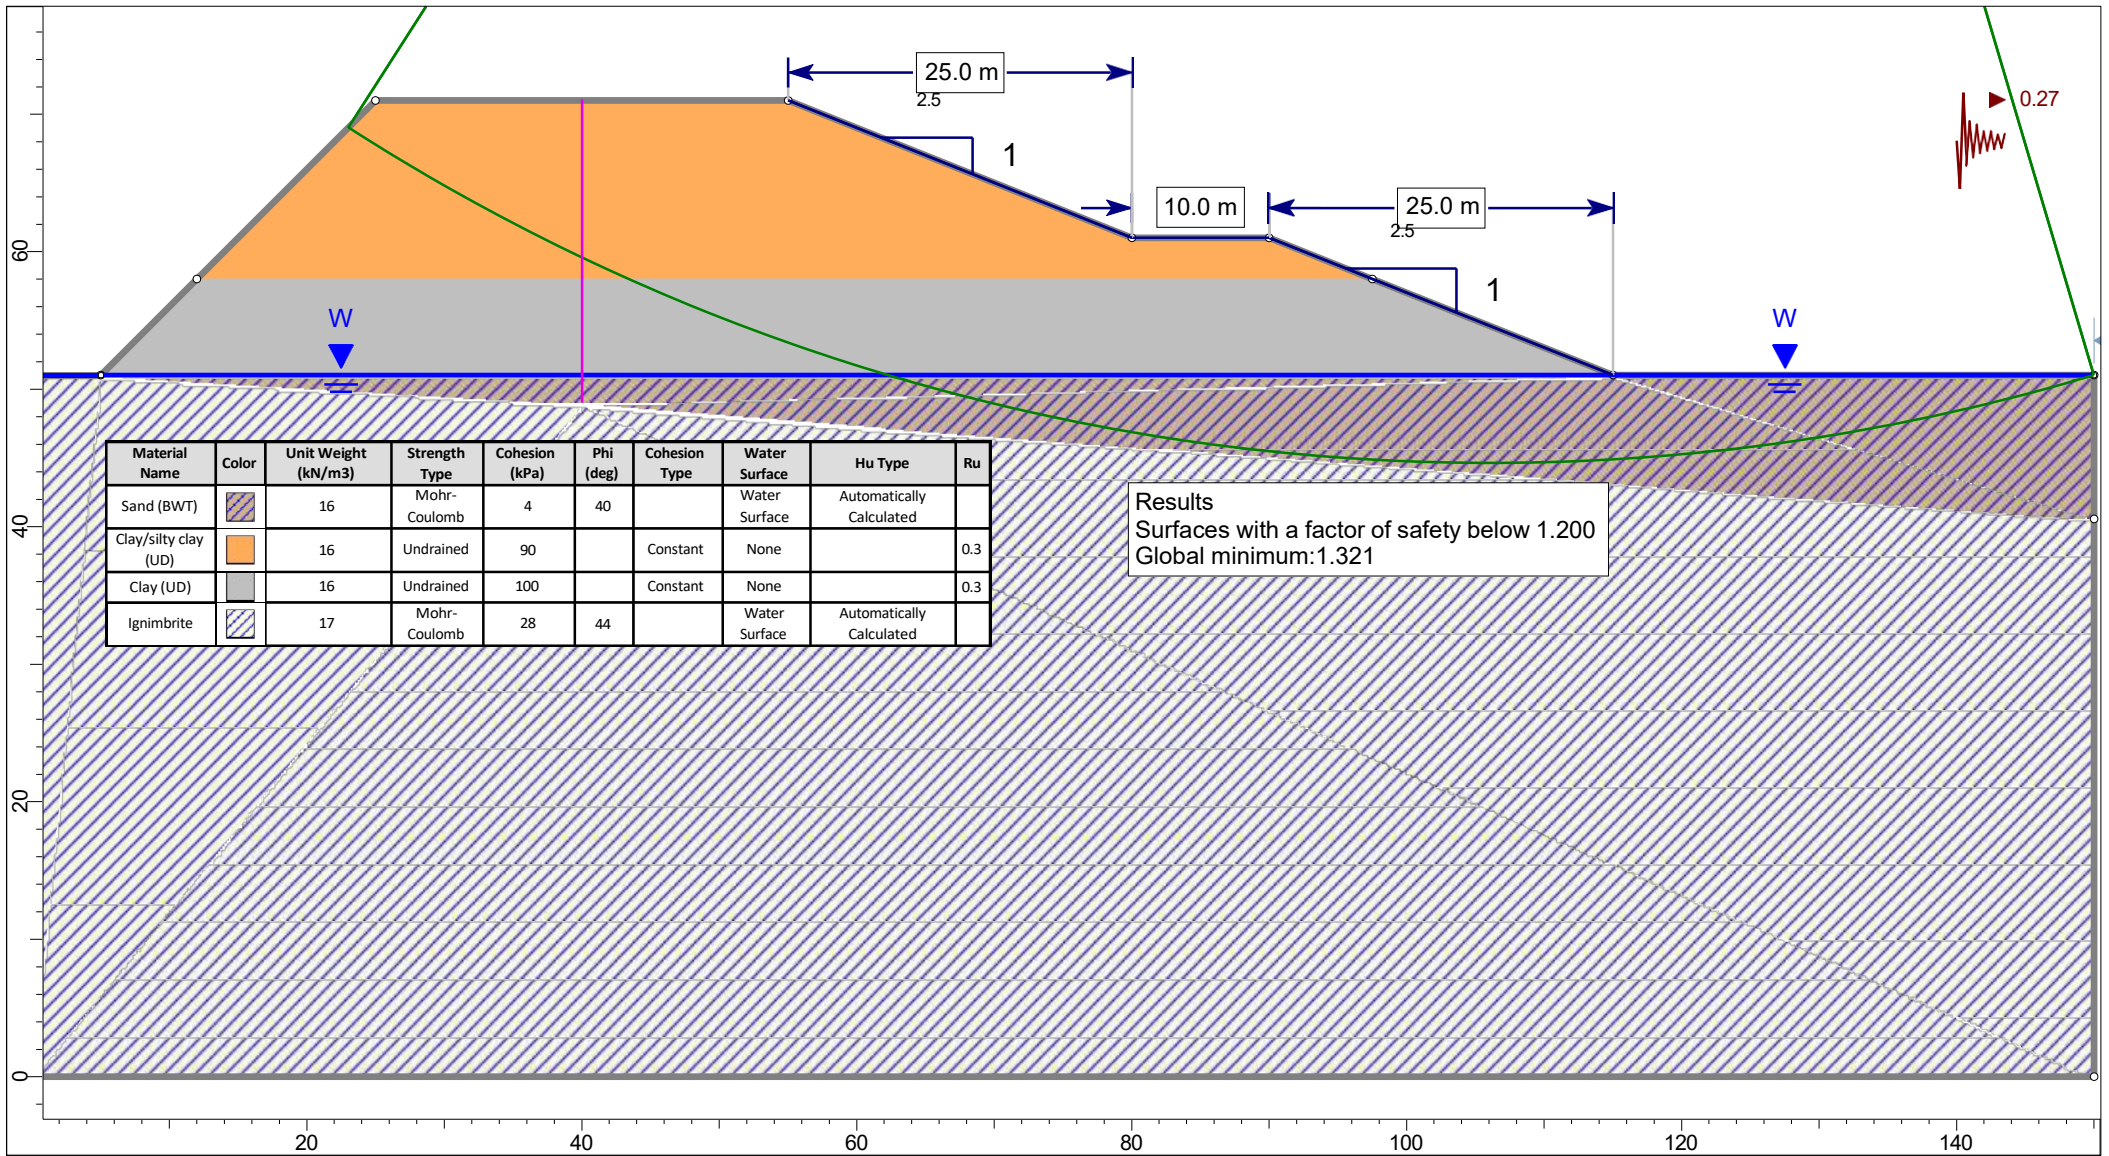
Results  
 Surfaces with a factor of safety below 1.200  
 Global minimum: 1.321

Project		599 Oreipunga Road, Maungatautari	
	Group	Stage 2 - Benched (2.5:1)	Scenario	Undrained, seismic
	Drawn By	Brad Kroef	Company	HD Geo Ltd
	Date	19/08/2021, 12:20:44 PM	File Name	HD2046_Slide (refined).slmd

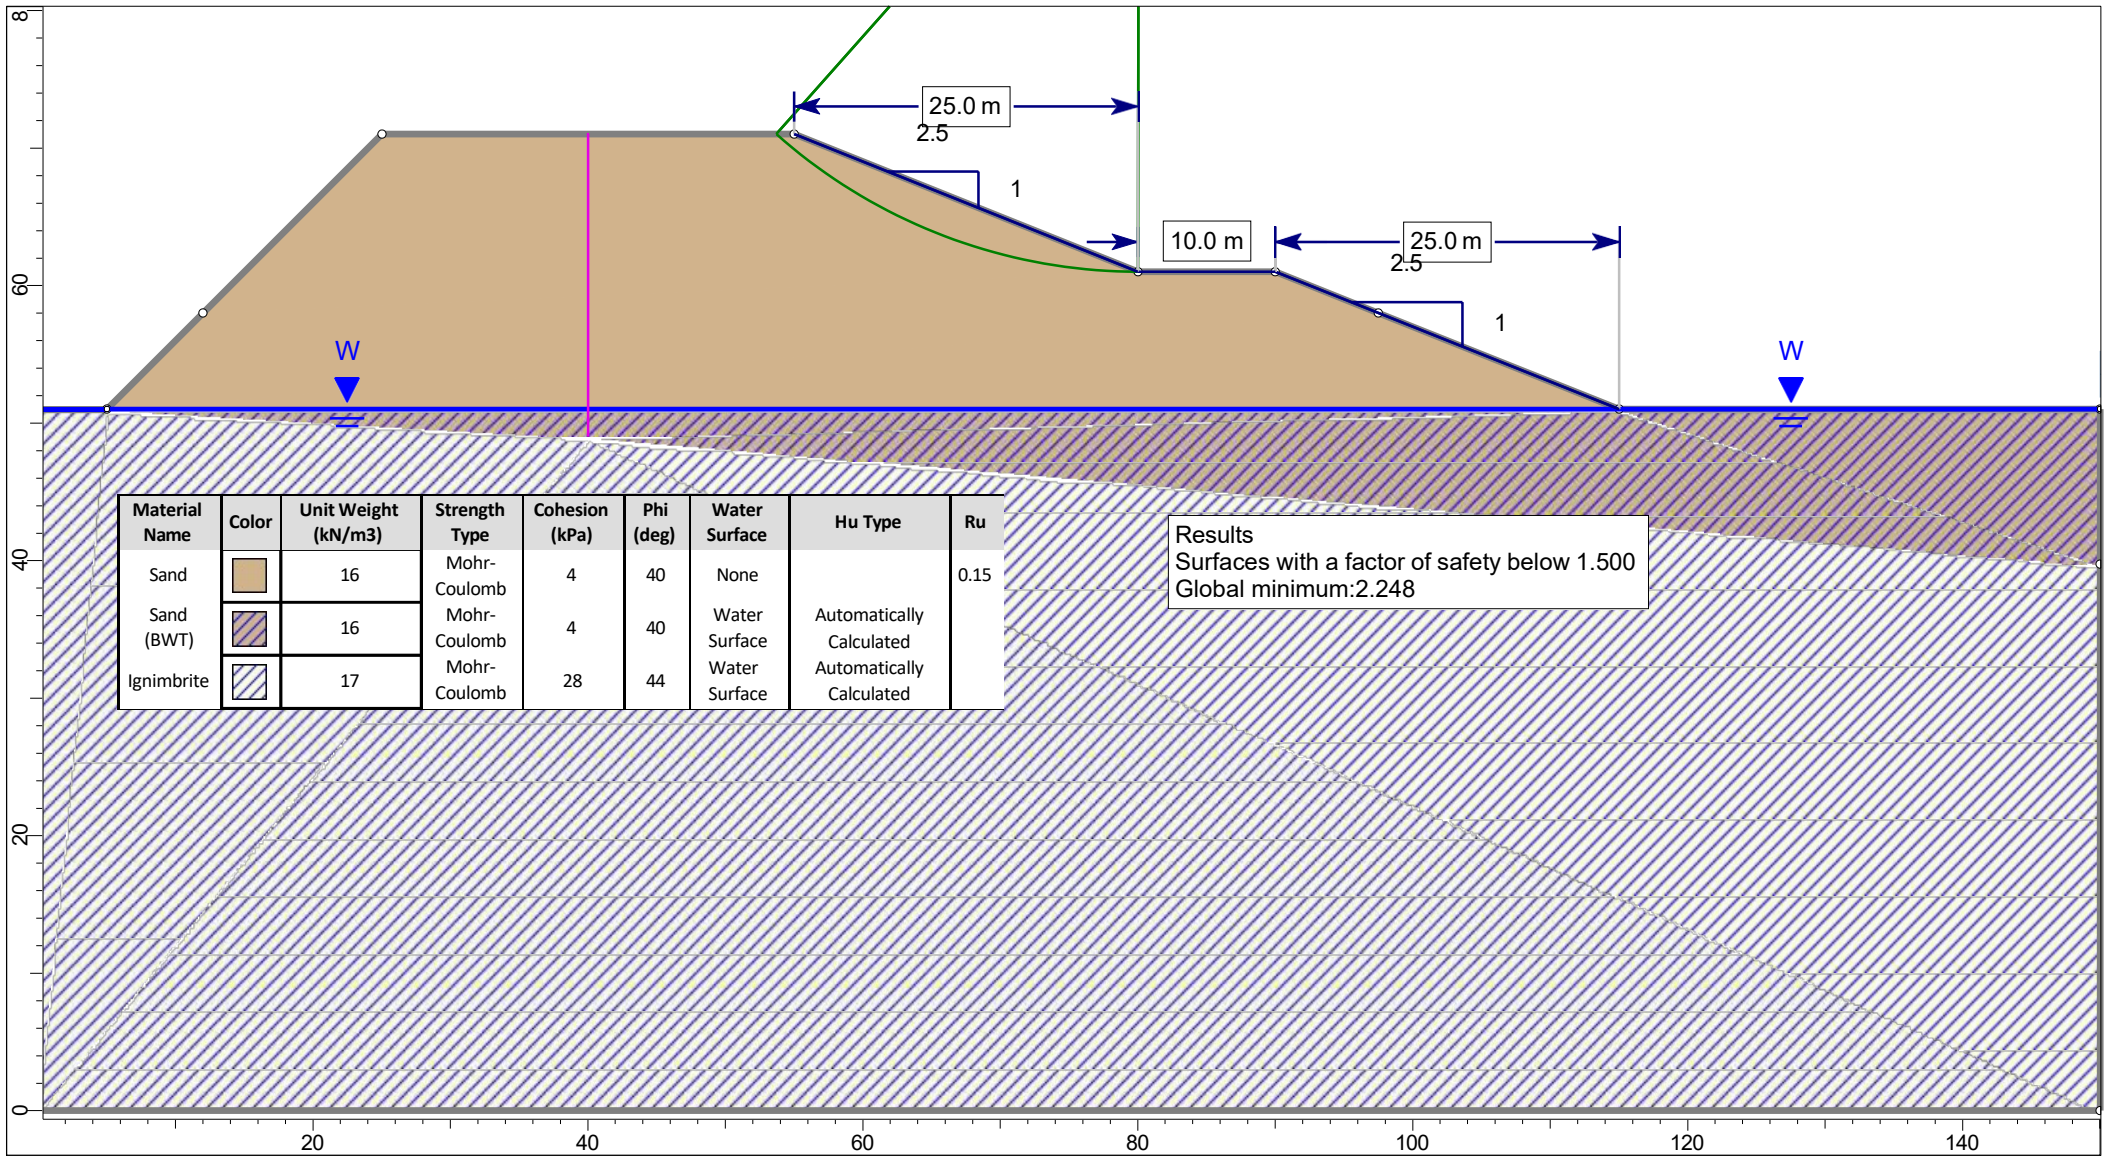
Project	599 Oreipunga Road, Maungatautari		
Group	Stage 2 - Benched (2.5:1) - Sand	Scenario	Drained
Drawn By	Brad Kroef	Company	HD Geo Ltd
Date	19/08/2021, 12:20:44 PM	File Name	HD2046_Slide (refined).slmd

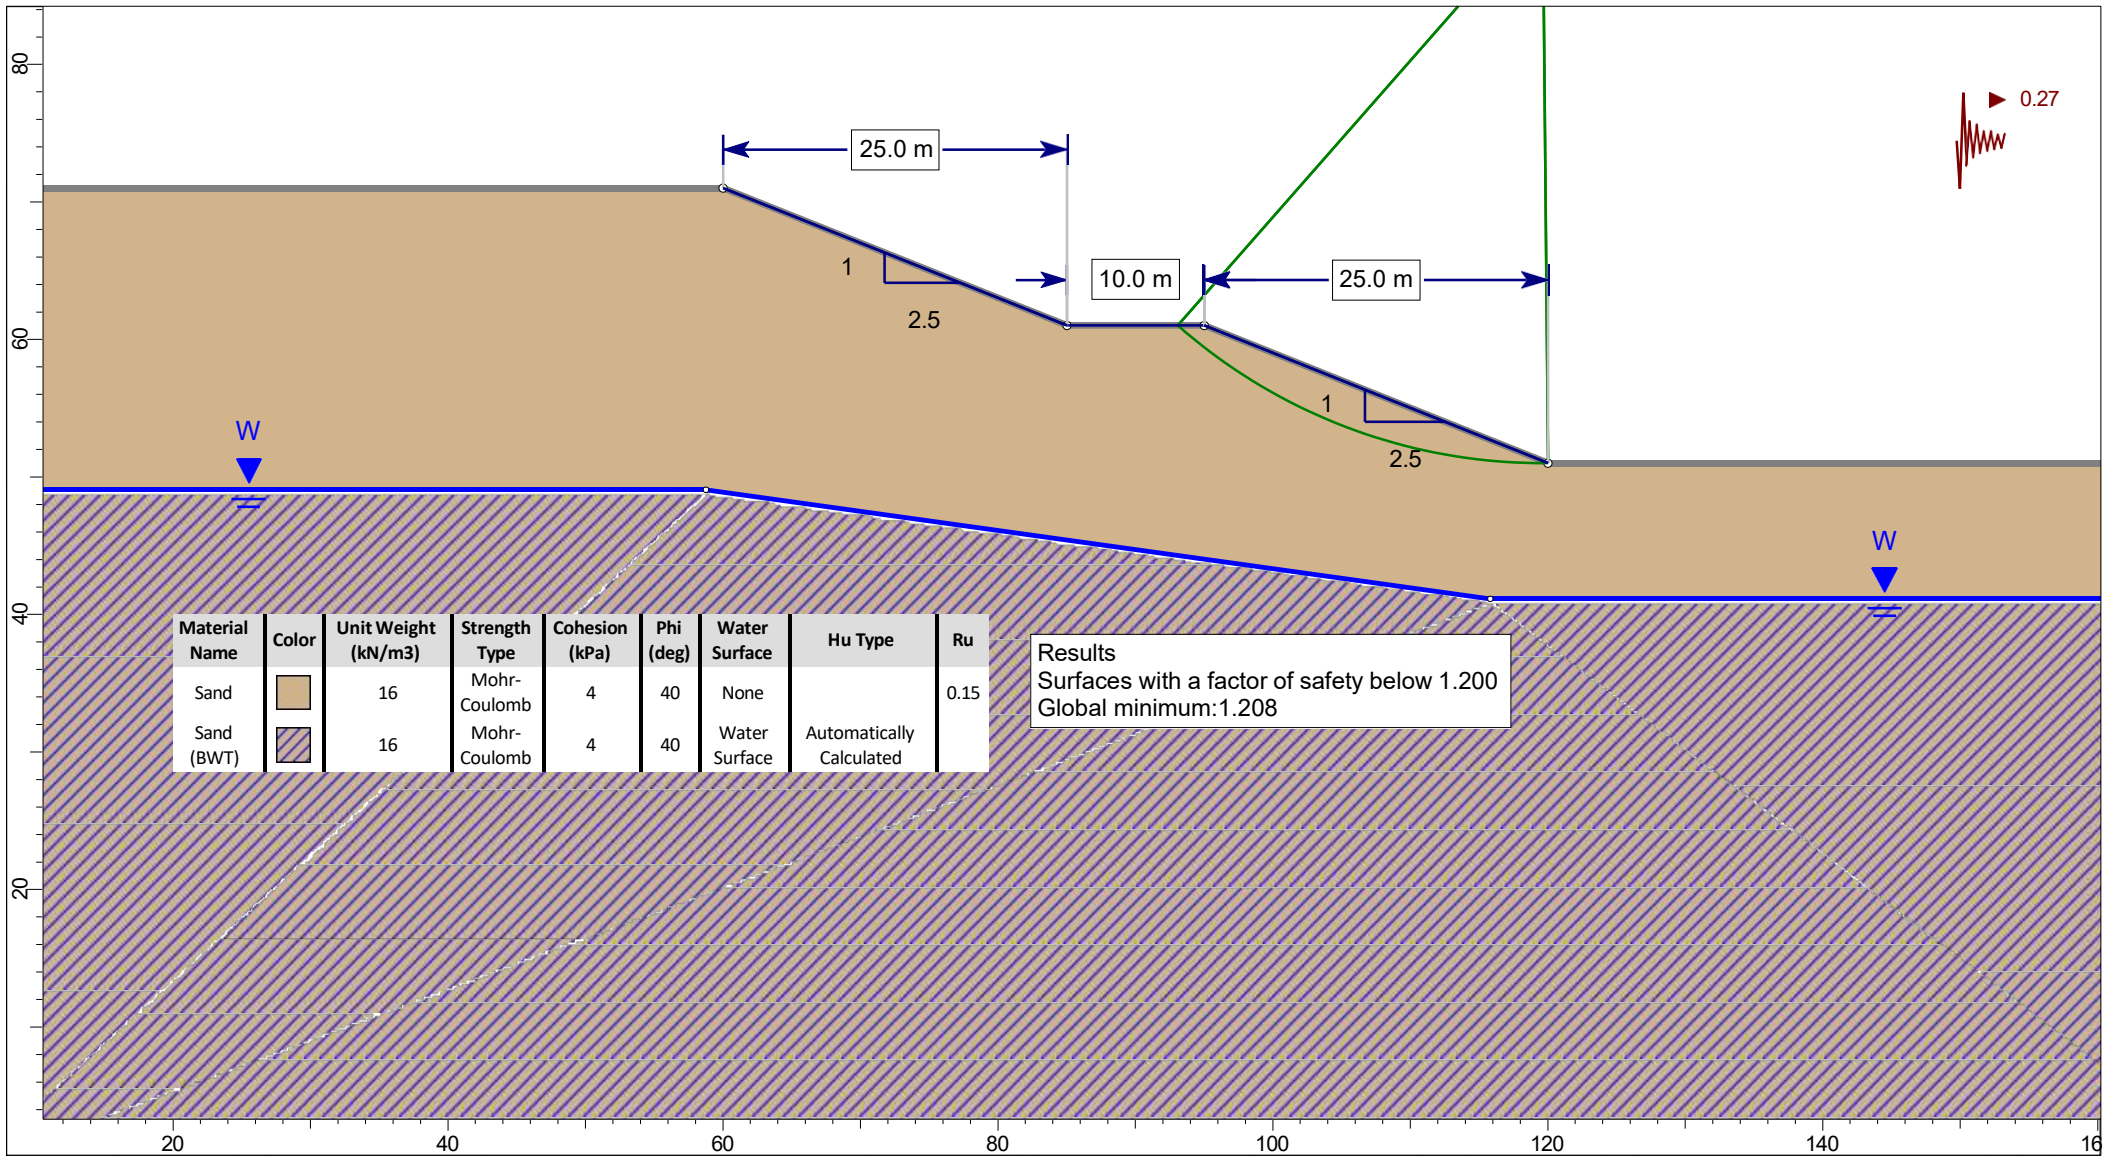
Material Name	Color	Unit Weight (kN/m3)	Strength Type	Cohesion (kPa)	Phi (deg)	Water Surface	Hu Type	Ru
Sand		16	Mohr-Coulomb	4	40	None		0.15
Sand (BWT)		16	Mohr-Coulomb	4	40	Water Surface	Automatically Calculated

Project		599 Oreipunga Road, Maungatautari	
	Group	General - Benched (2.5:1)	Scenario	Drained, seismic
	Drawn By	Brad Kroef	Company	HD Geo Ltd
	Date	19/08/2021, 12:20:44 PM	File Name	HD2046_Slide (refined).slmd
