Preliminary Geotechnical Assessment  
– HdGeo

**599 OREIPUNGA  
ROAD,  
MAUNGATAUTARI**

**PRELIMINARY  
GEOTECHNICAL  
ASSESSMENT**

PROJECT NO: HD2046  
MARK ANDREE-WILTENS  
REFERENCE: PGR  
27 AUGUST 2021

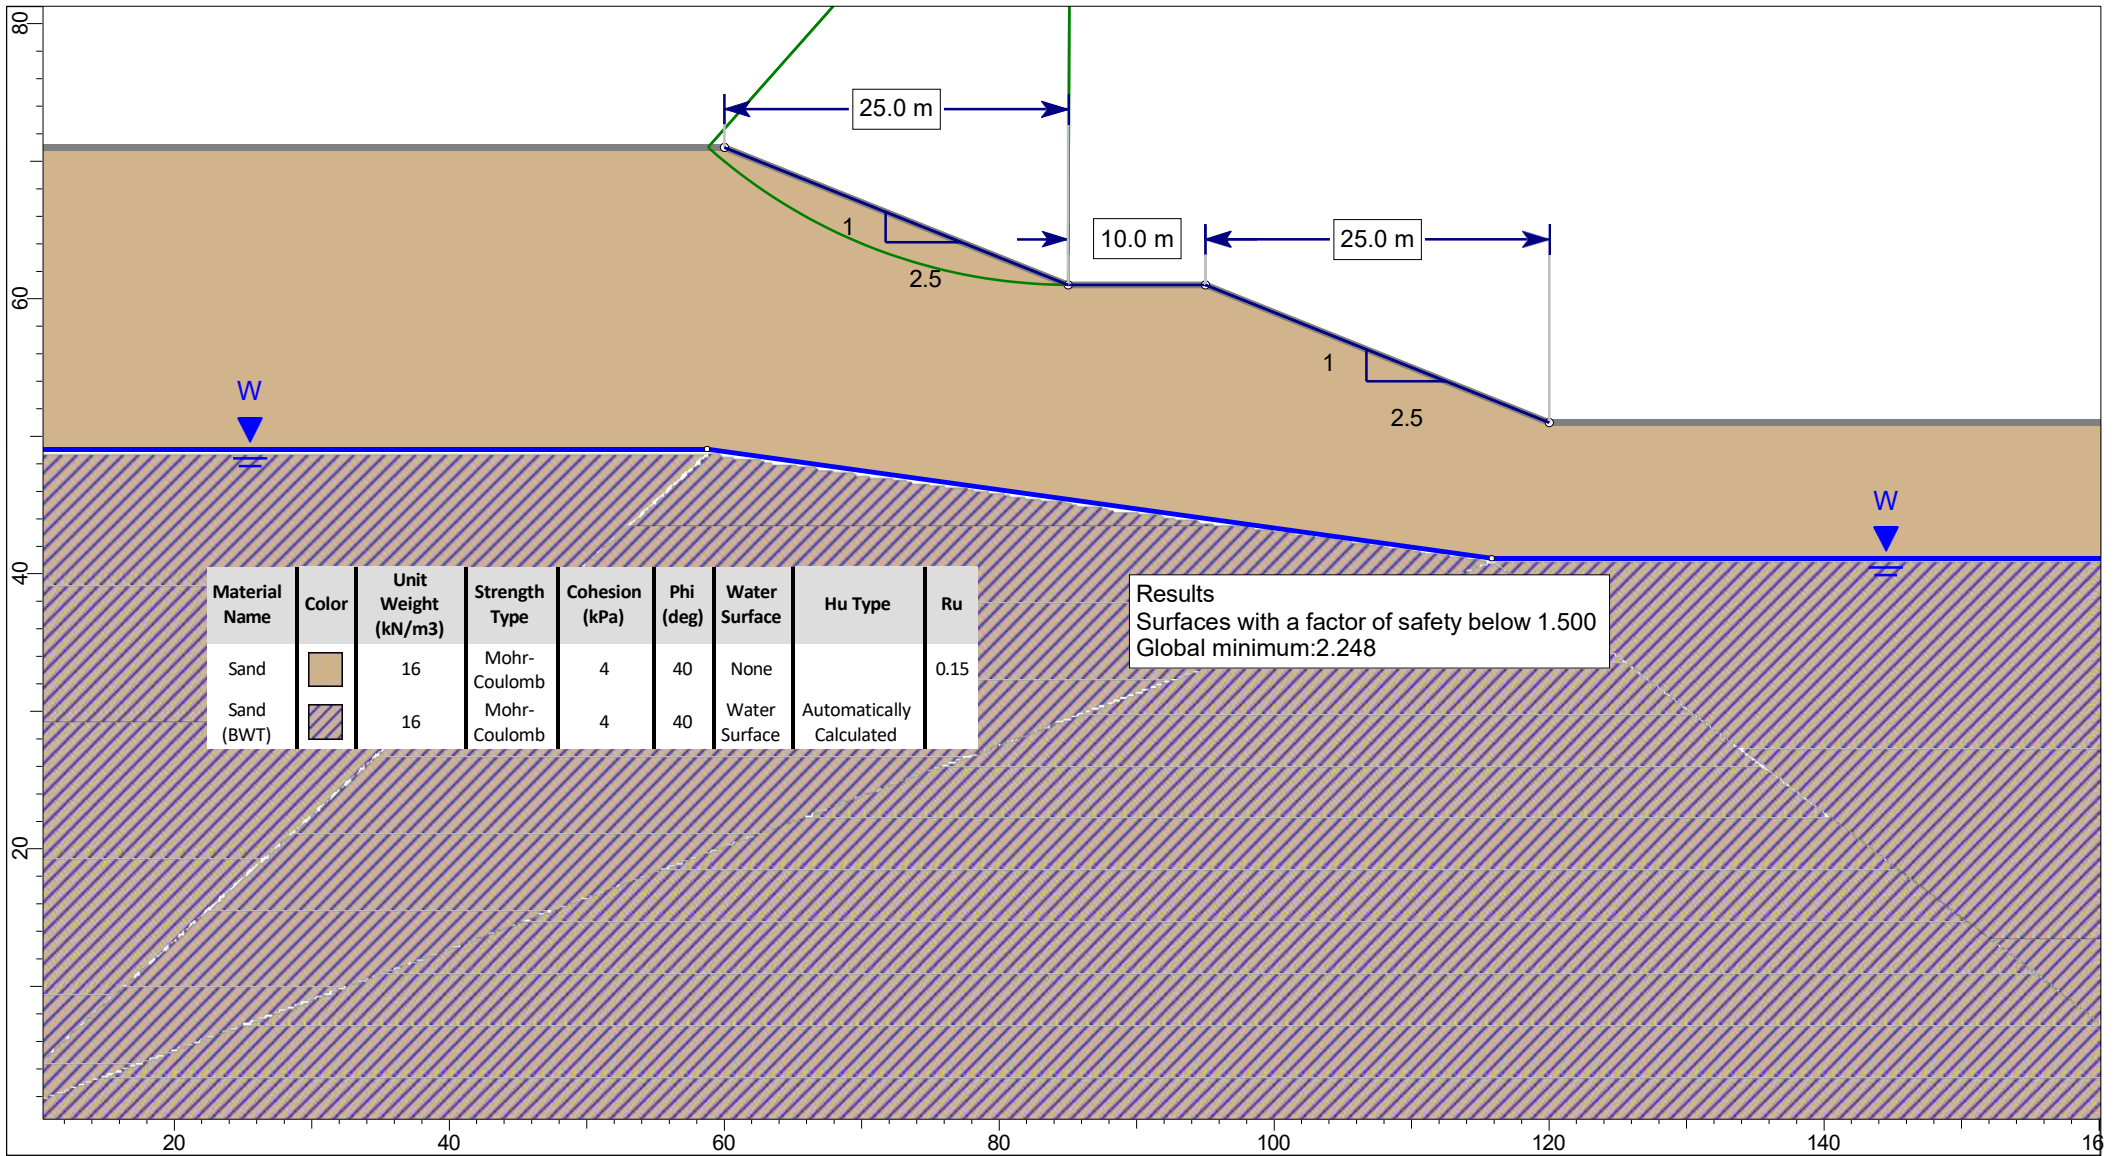
Material Name	Color	Unit Weight (kN/m <sup>3</sup> )	Strength Type	Cohesion (kPa)	Phi (deg)	Water Surface	Hu Type	Ru
Sand	 	16	Mohr-Coulomb	4	40	None		0.15
Sand (BWT)	 	16	Mohr-Coulomb	4	40	Water Surface	Automatically Calculated

Results  
Surfaces with a factor of safety below 1.500  
Global minimum: 2.248

Project	599 Oreipunga Road, Maungatautari		
Group	General - Benched (2.5:1)	Scenario	Drained
Drawn By	Brad Kroef	Company	HD Geo Ltd
Date	19/08/2021, 12:20:44 PM	File Name	HD2046_Slide (refined).slmd

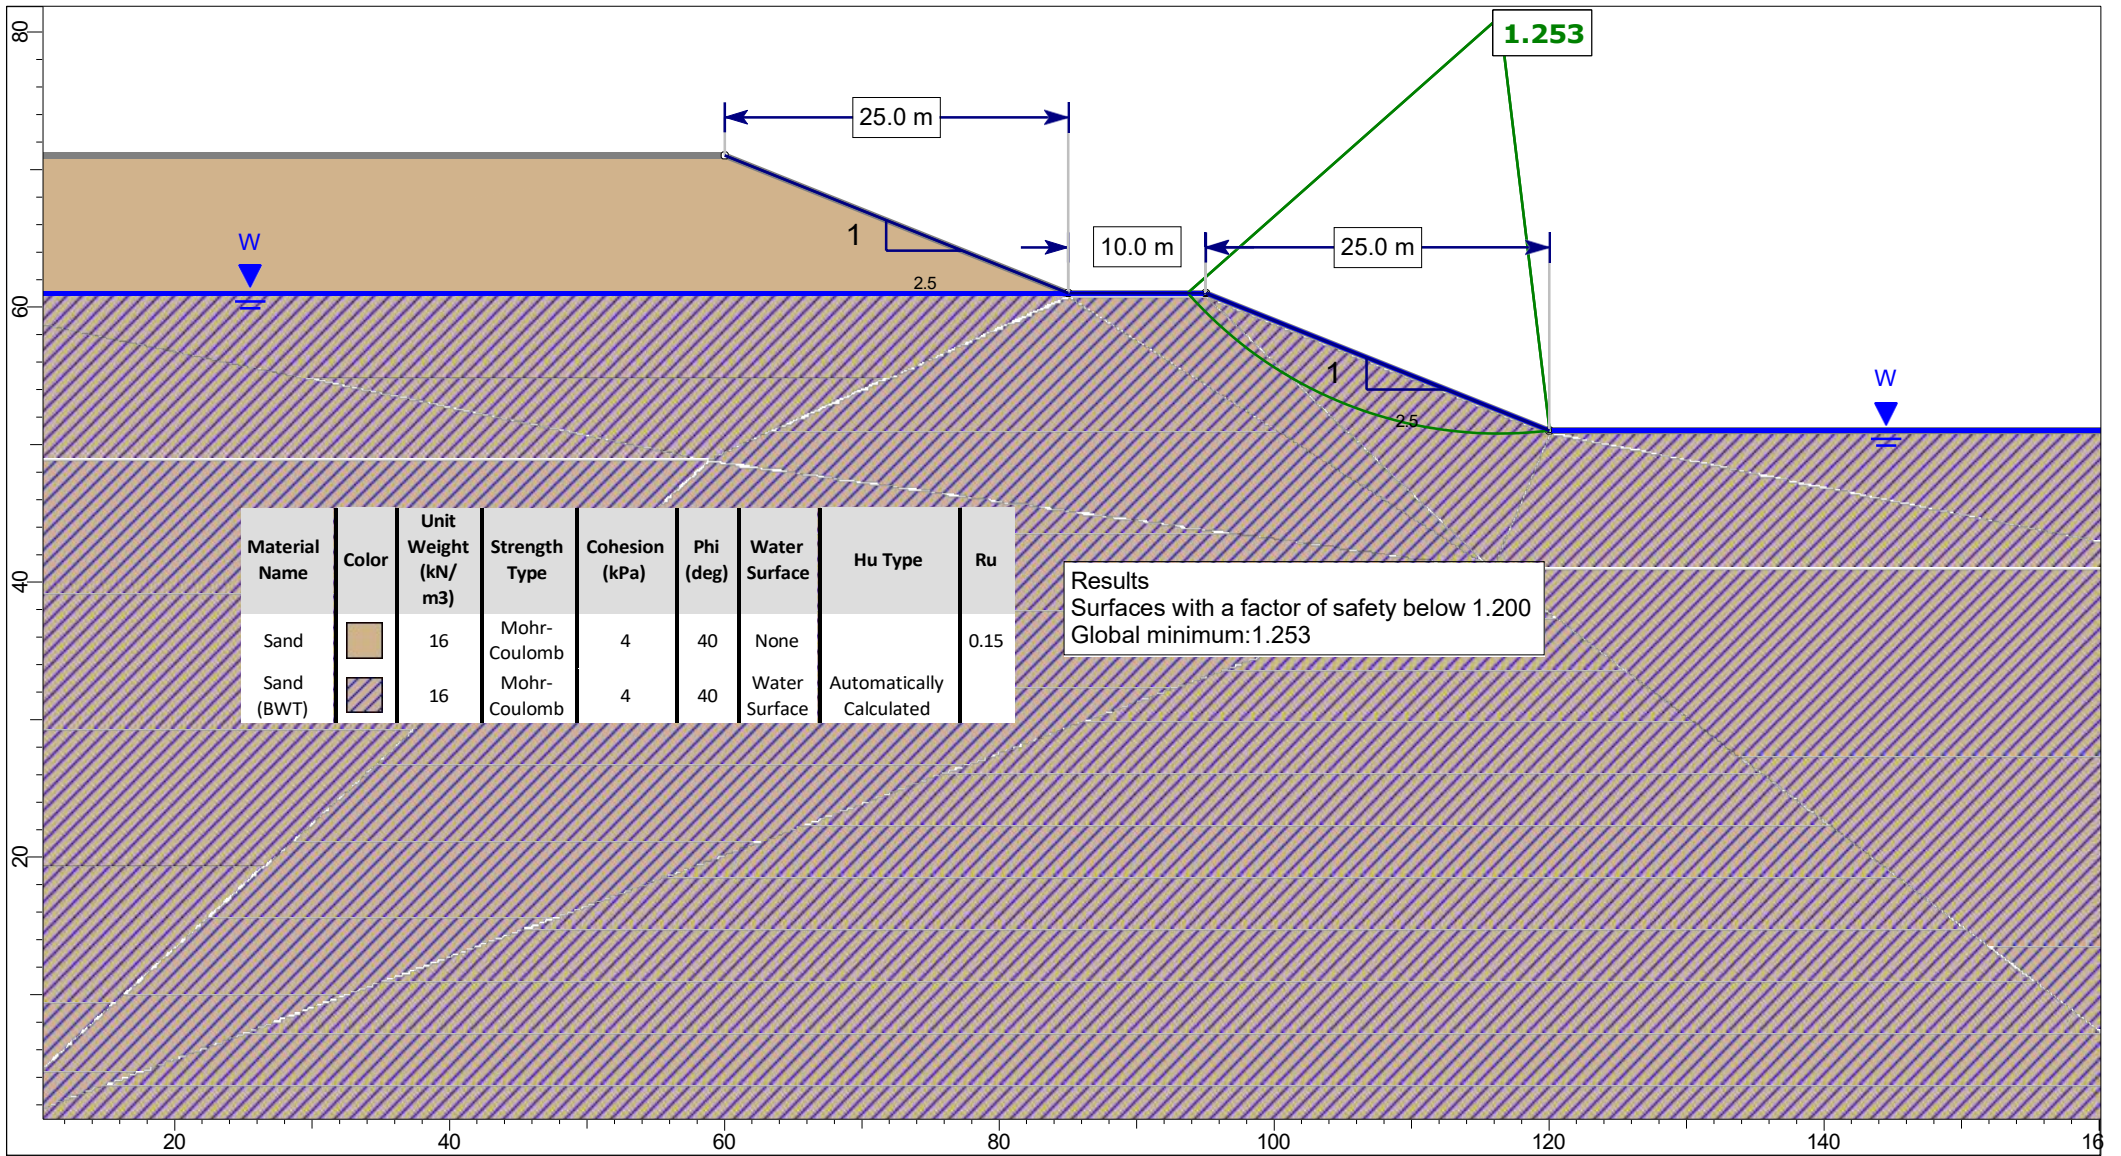
Material Name	Color	Unit Weight (kN/m <sup>3</sup> )	Strength Type	Cohesion (kPa)	Phi (deg)	Water Surface	Hu Type	Ru
Sand		16	Mohr-Coulomb	4	40	None		0.15
Sand (BWT)		16	Mohr-Coulomb	4	40	Water Surface	Automatically Calculated

Results  
 Surfaces with a factor of safety below 1.200  
 Global minimum: 1.253

Project			599 Oreipunga Road, Maungatautari		
	Group			General - Benched (2.5:1)		
	Scenario			Drained, elevated GWT		
	Drawn By			Brad Kroef		
Date			19/08/2021, 12:20:44 PM			
Company			HD Geo Ltd			
File Name			HD2046_Slide (refined).slmd
