Environment Waikato Technical Report 2006/20

Buffalo Beach Coastal Erosion Management Strategy : Part II – Technical Appendices

Prepared by:
Beca Carter Hollings & Ferner Ltd,
in association with Economos Ltd and Covec

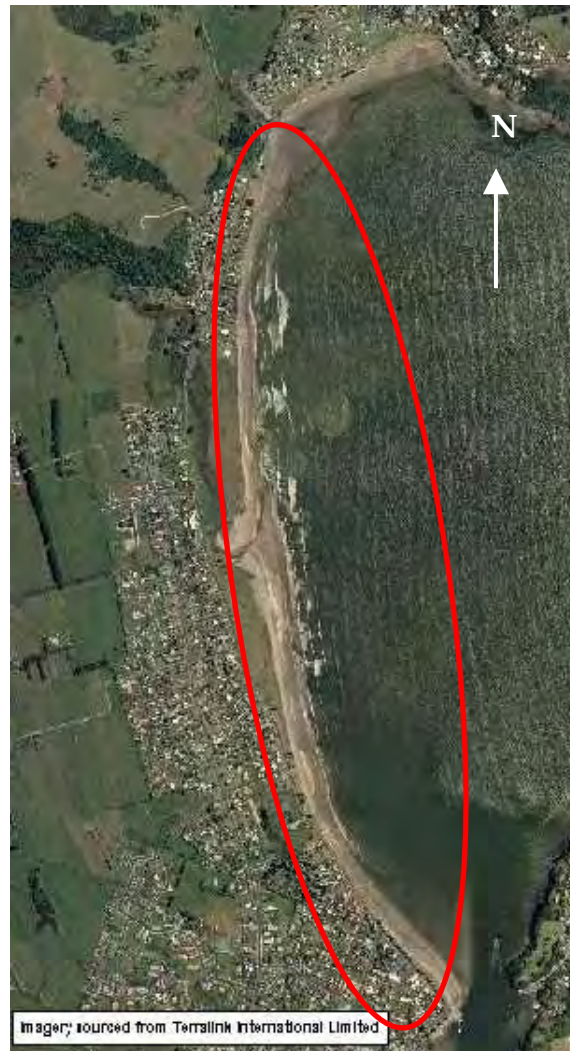
Figure 1: Buffalo Beach Coastal Erosion Management Strategy boundaries

As seen in Figure 1, the Buffalo Beach strategy area has differing levels of development along the foreshore and therefore differing levels of coastal erosion hazard. It was therefore considered necessary to divide the Buffalo Beach study area into sections depending on the existing level of development/infrastructure and the level of present and potential future coastal erosion hazard. The divisions are shown in Figures 2a, 2b and 2c and are described as:

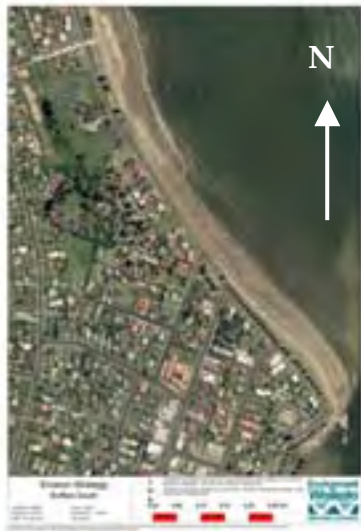
Figure 2 (a): Buffalo Beach Southern Section

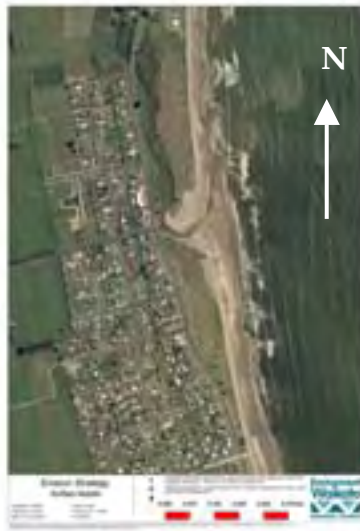
Figure 2(b): Buffalo Beach Mid Section

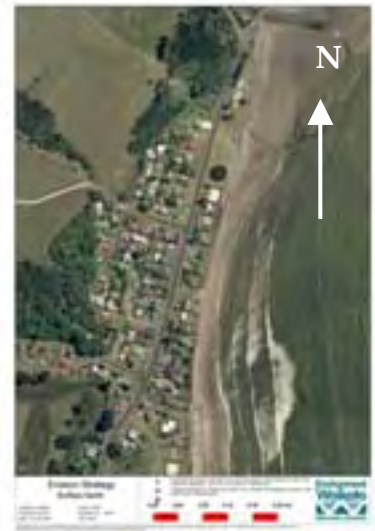
Figure 2 (c): Buffalo Beach Northern Section

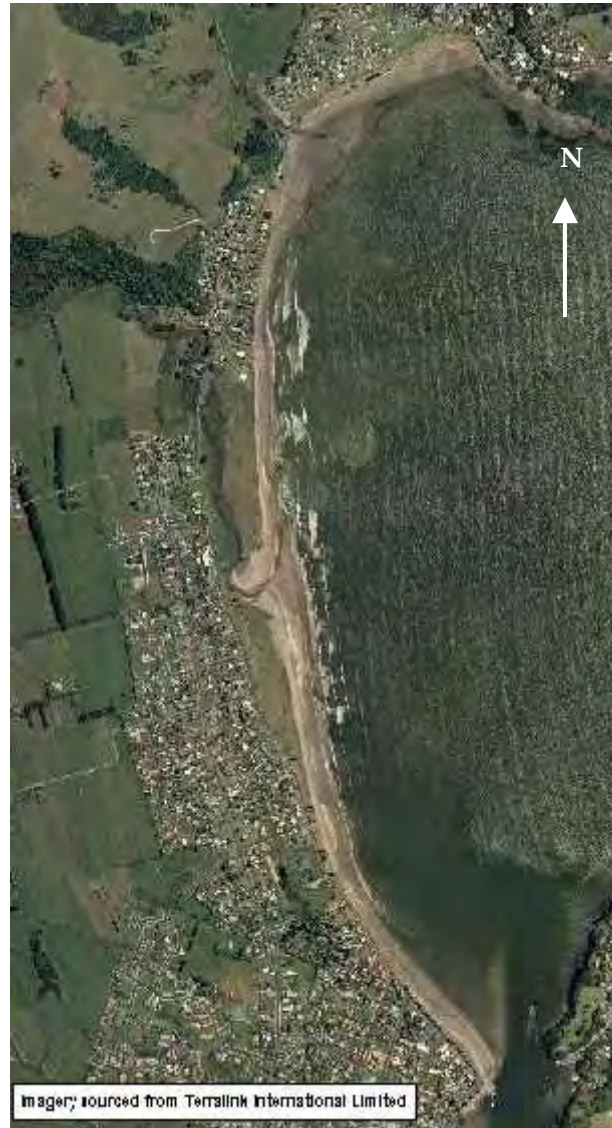
Figure 1: Buffalo Beach showing Whitianga Estuary entrance to the south. Note the ebb tidal delta.

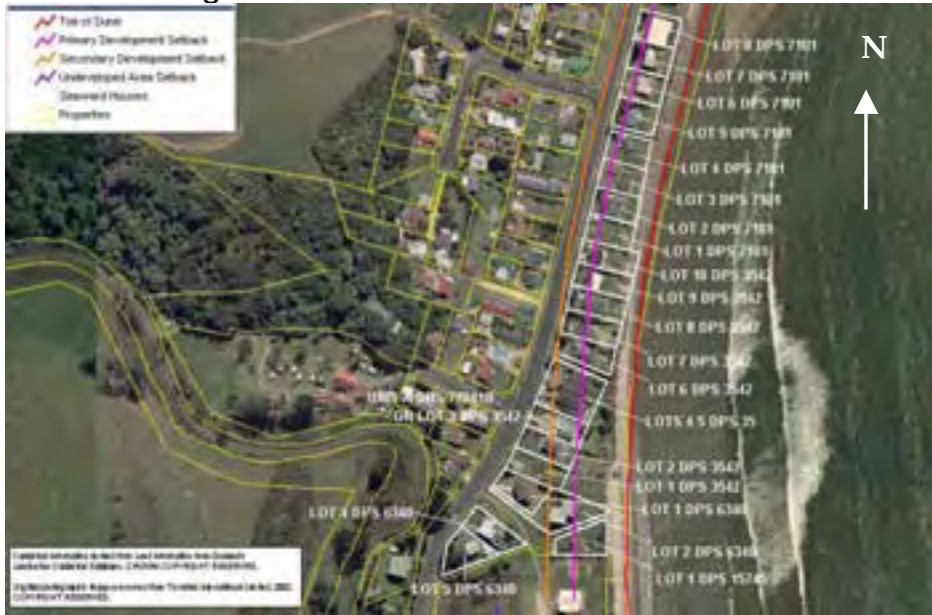
Figure 2: Buffalo Beach North Hazard Lines

The setback lines (Figure 2, 3 and 4) recently developed by Environment Waikato provide the best present estimates of the area vulnerable to erosion hazard, though these setbacks are probably precautionary. More detailed site-specific investigation and analysis would be required to refine these estimates.

In response to the erosion problems at Cooks Beach and other sites, TCDC introduced 30m and 60m hazard setbacks at all developed beaches along the Coromandel east coast in the early 1980's (Figures 2, 3 and 4).

The 30m setback defines the area potentially at high risk from coastal erosion. New buildings are excluded in this area, including the replacement of existing dwellings unless a site-specific hazard assessment indicates that a lesser hazard zone is appropriate. The 30-60m setback identifies a lower risk area, unlikely to be impacted unless erosion is aggravated by sea level rise or other changes. New dwellings are usually consented within this area, conditional on relocatability and a damage waiver indemnifying Council. A Section 36 notice is also normally imposed.

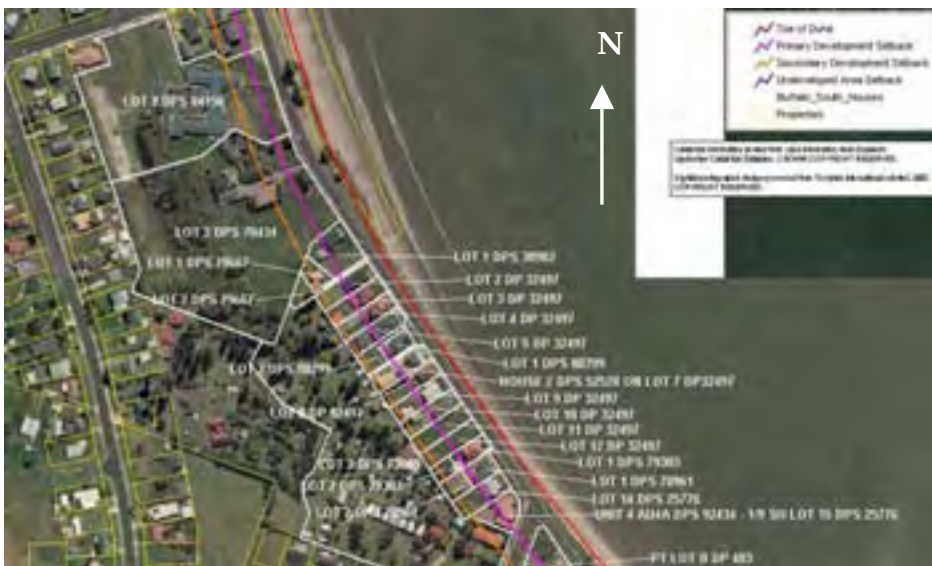
Figure 3: Buffalo Beach South (top) Hazard Lines

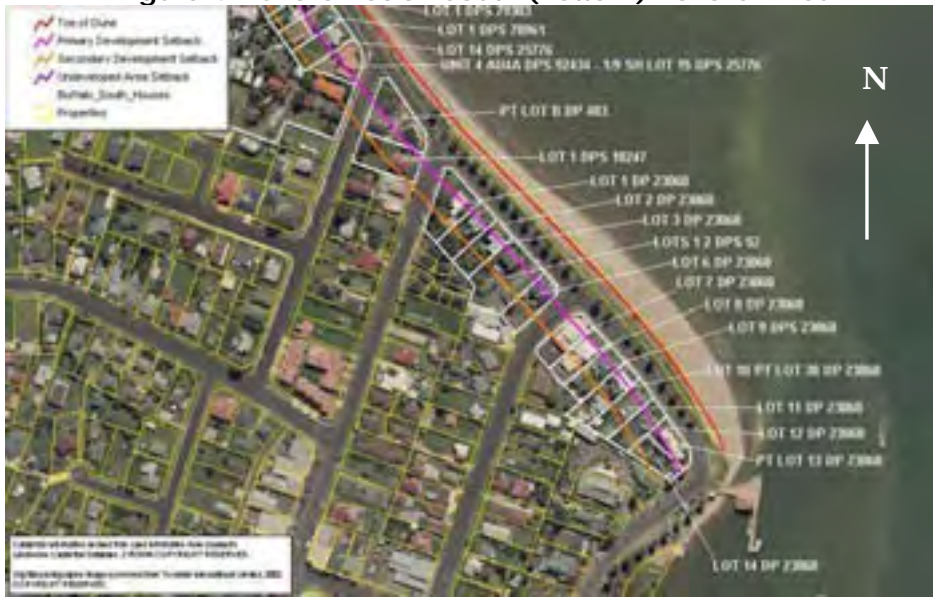
Figure 4: Buffalo Beach South (Bottom) Hazard Lines

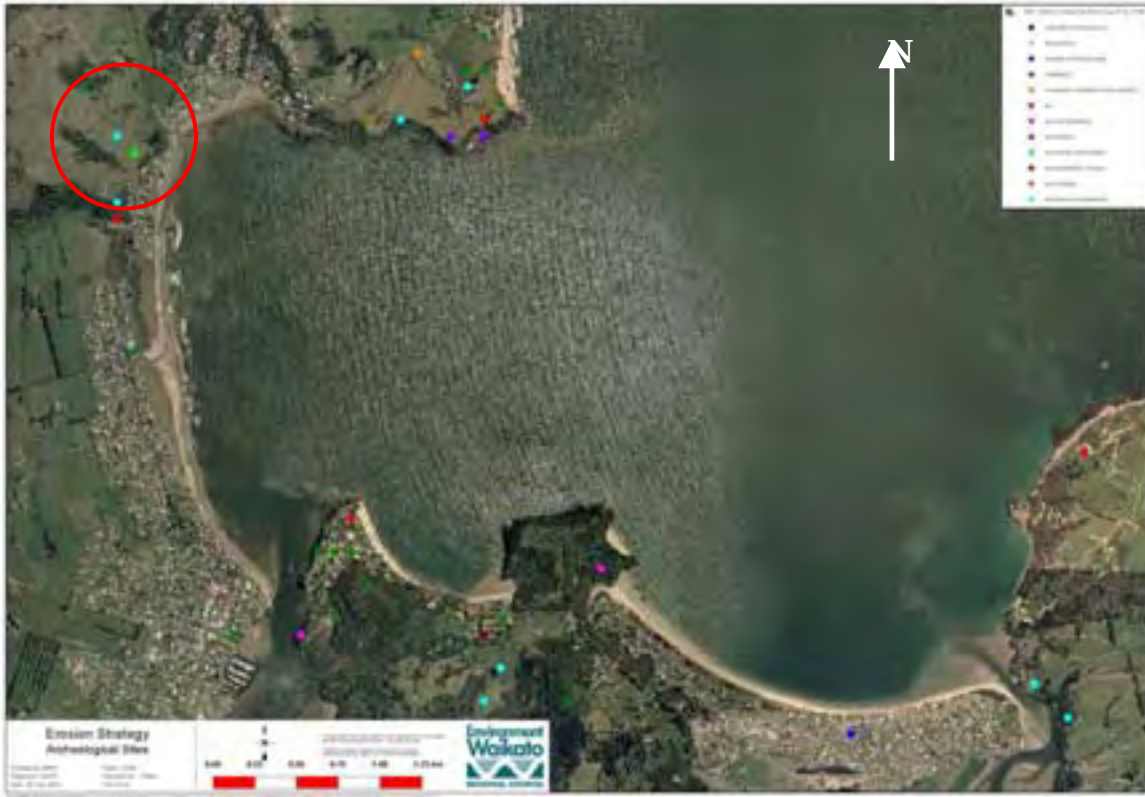
Figure 5: Archaeological sites for Whitianga and Cooks Beach held in EW register.

The HMS BUFFALO was wrecked in a storm at Mercury Bay on 29 July 1840 and therefore is an important archaeological site offshore of Buffalo Beach (although its location is not clear). This wreck has protection under the Historic Places Act 1980.
